ADDENDUM NO. 01

PROJECT: **WCU Reid Building Roof Replacement**
Western Carolina University, Cullowhee, NC
SCO ID#: 22-24547-01A
Atlas Engineering Job No. J2626

REPORT SUMMARIZING ROOF MATERIALS BULK SAMPLING ANALYSIS RESULTS TO DETERMINE ASBESTOS CONTENT

**WESTERN CAROLINA UNIVERSITY
REID HEALTH AND HUMAN PERFORMANCE BUILDING
ROOF SYSTEMS REPLACEMENT PROJECT
MEMORIAL AND CULLOWHEE DRIVES
CULLOWHEE, NORTH CAROLINA 28723
PROJECT NO.: OLME-2022-18**

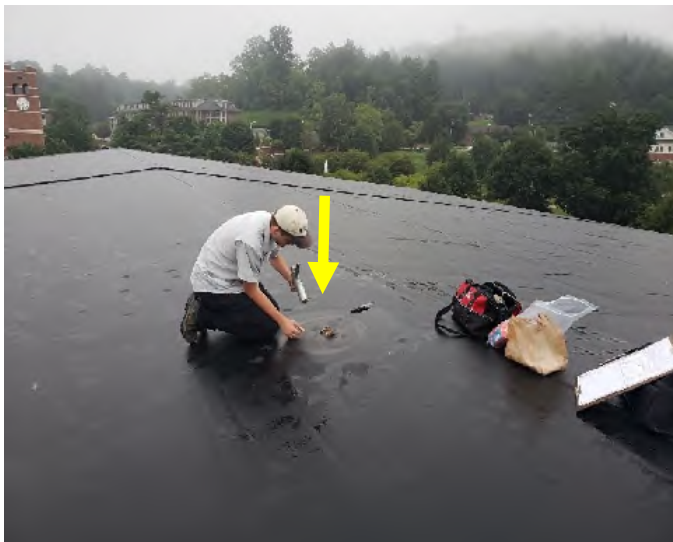
PHOTO No. 7
View of the Location for Roof Core **Sample WCRB-1 (C-1)**
Obtained from Center of Roof (Area) A1 (**None Detected**)

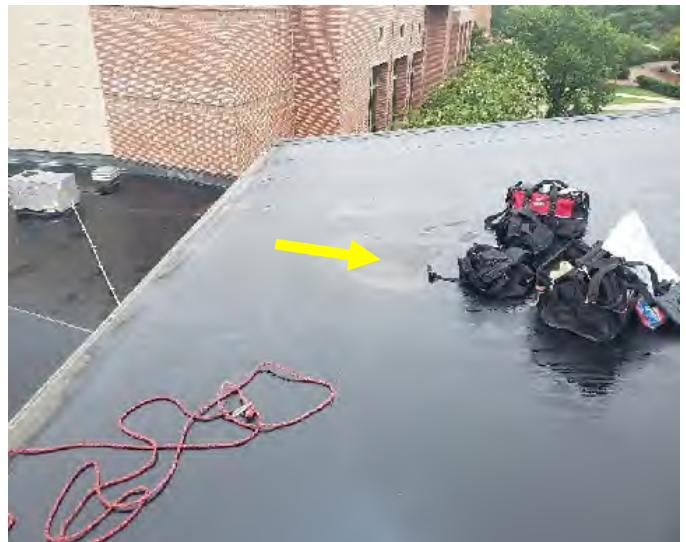
PHOTO No. 8
View of the Location for Roof Core **Sample WCRB-2 (C-2)**
Obtained from Northeast Corner of Roof (Area) A1
(**None Detected**)

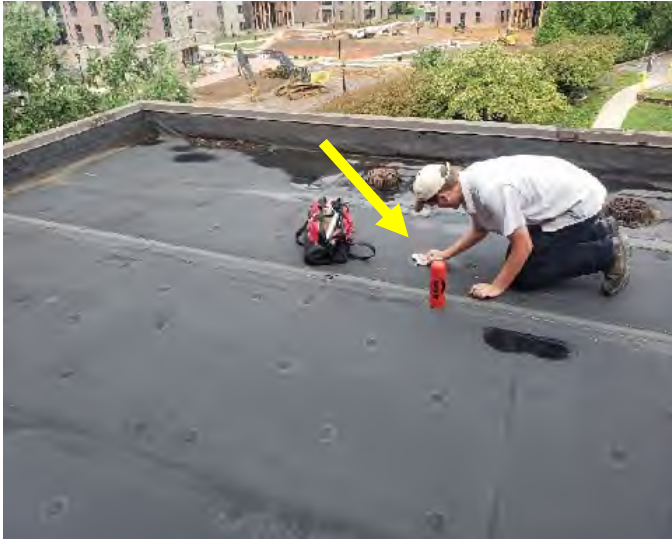
PHOTO No. 9

View of the Location for Roof Core **Sample WCRB-3 (C-3)**
Obtained from Southwest Corner of Roof (Area) D1
(Black Mastic Contains 3% Chrysotile Asbestos)

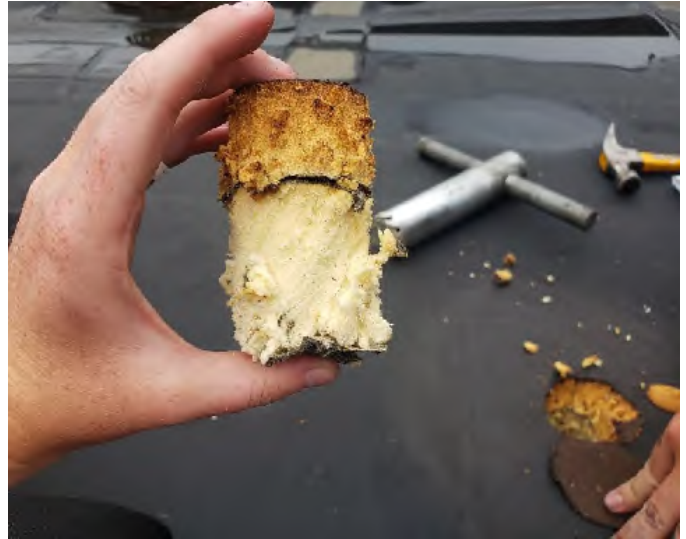
PHOTO No. 10

Closer View of Roof Core **Sample WCRB-3 (C-3)** Obtained
from Southwest Corner of Roof (Area) D1
(Black Mastic Contains 3% Chrysotile Asbestos)

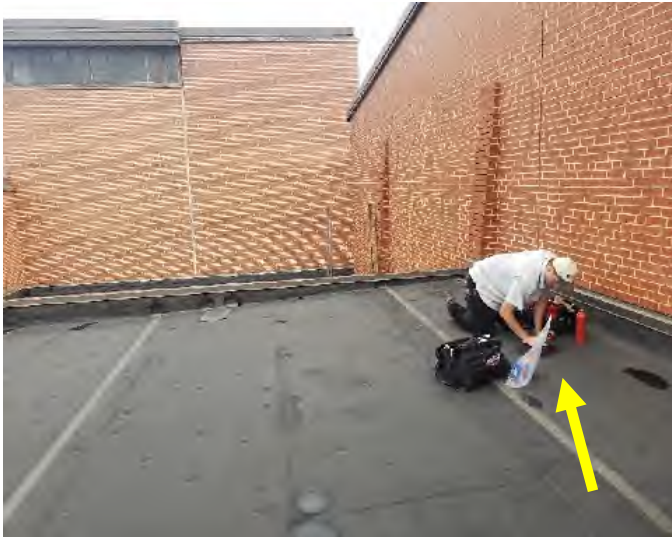
PHOTO No. 11

View of the Location for Roof Core **Sample WCRB-4 (C-4)**
Obtained from Northeast Corner of Roof (Area) D1
(Black Mastic Contains 3% Chrysotile Asbestos)

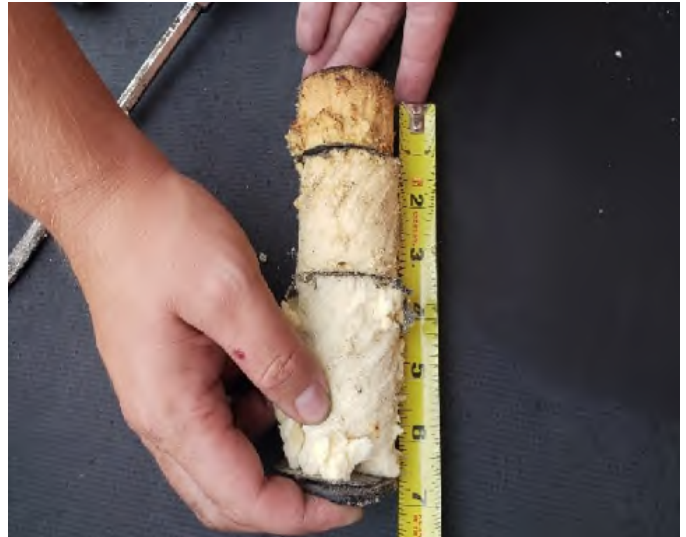
PHOTO No. 12

Closer View of Roof Core **Sample WCRB-4 (C-4)** Obtained
from Northeast Corner of Roof (Area) D1
(Black Mastic Contains 3% Chrysotile Asbestos)

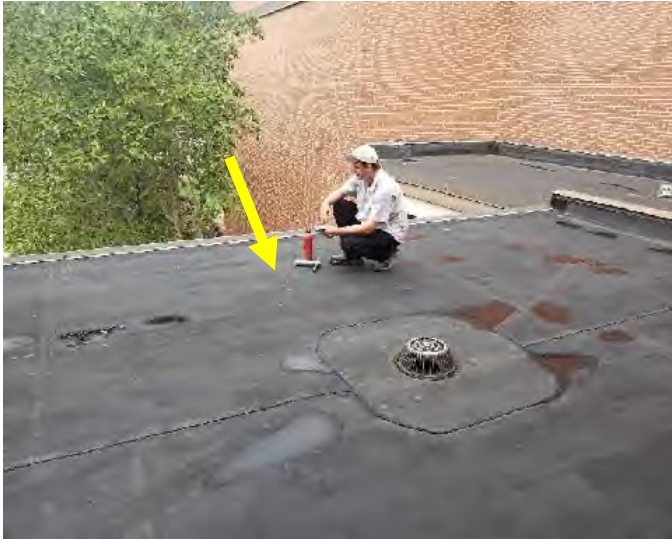
PHOTO No. 13

View of the Location for Roof Core **Sample WCRB-5 (C-5)**
Obtained from Center of Roof (Area) U4 (**None Detected**)

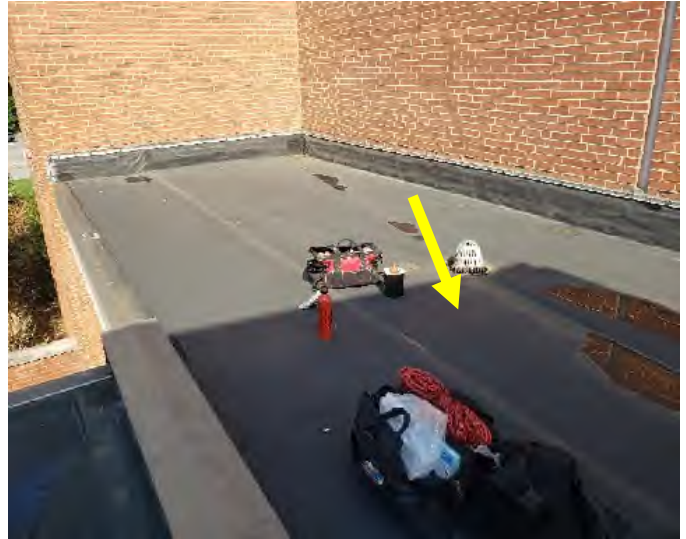
PHOTO No. 14

View of the Location for Roof Core **Sample WCRB-6 (C-6)**
Obtained from Center of Roof (Area) C6 (**None Detected**)

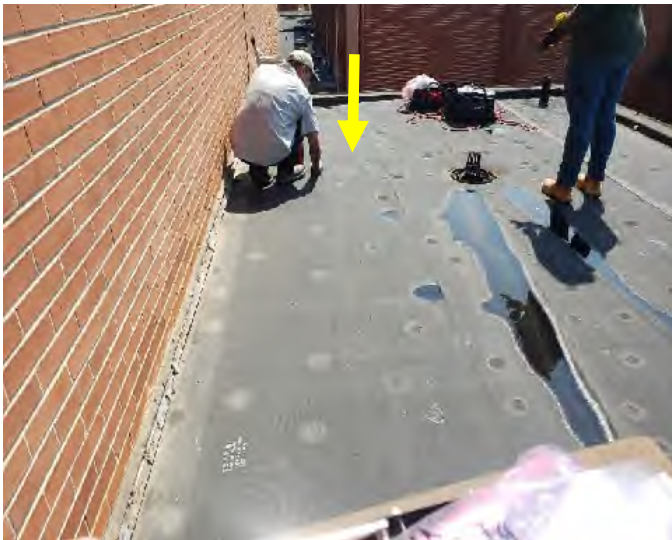
PHOTO No. 15

View of the Location for Roof Core **Sample WCRB-7 (C-7)**
Obtained from Northeast Corner of Roof (Area) C2
(**None Detected**)

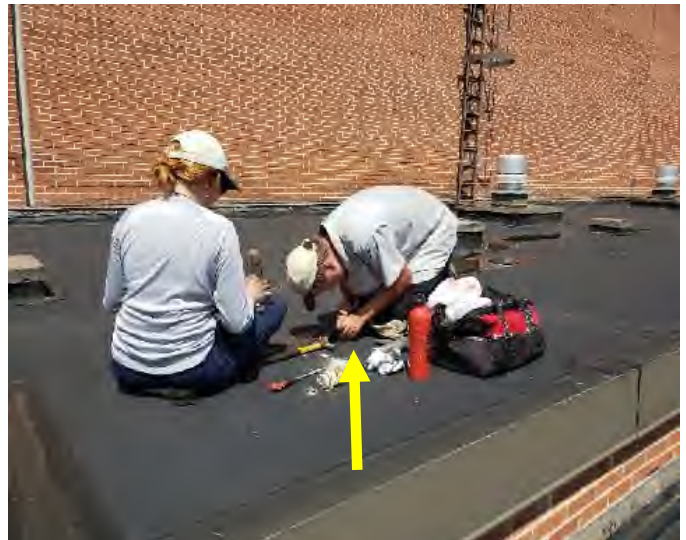
PHOTO No. 16

View of the Location for Roof Core **Sample WCRB-8 (C-8)**
Obtained from East Side of Roof (Area) C5 (**None Detected**)

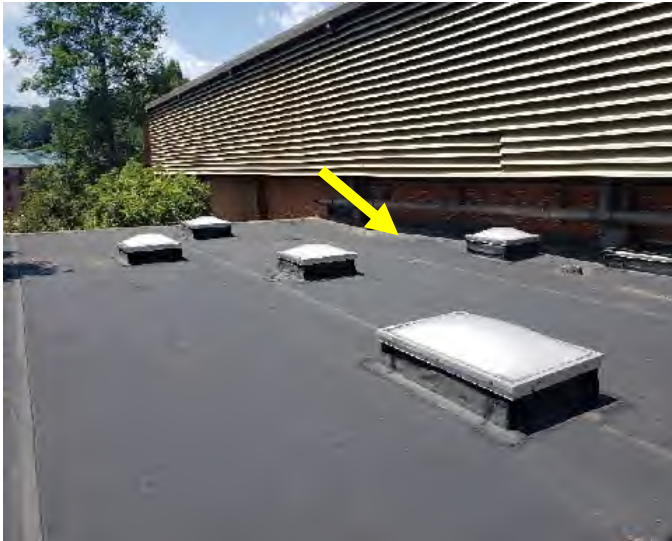
PHOTO No. 17

View of the Location for Roof Core **Sample WCRB-9 (C-9)** Obtained from Southern Portion of Roof (Area) A2
(None Detected)

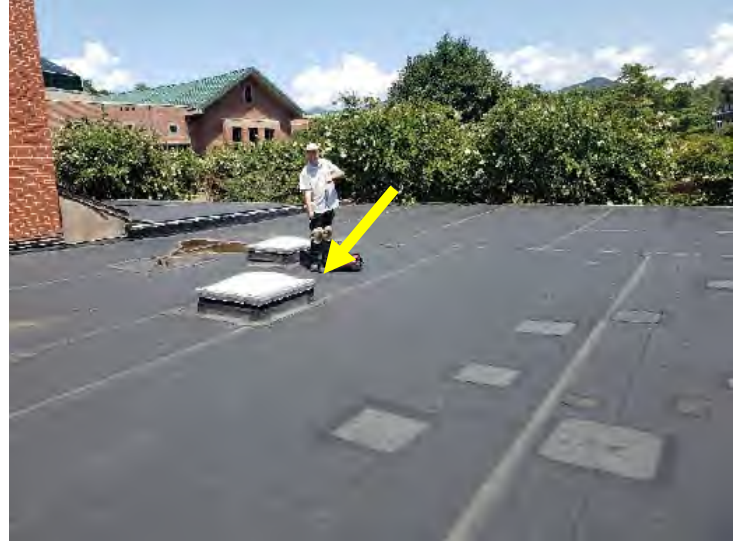
PHOTO No. 18

View of the Location for Roof Core **Sample WCRB-10 (C-10)** Obtained from Southeast Section of Roof (Area) A2
(None Detected)

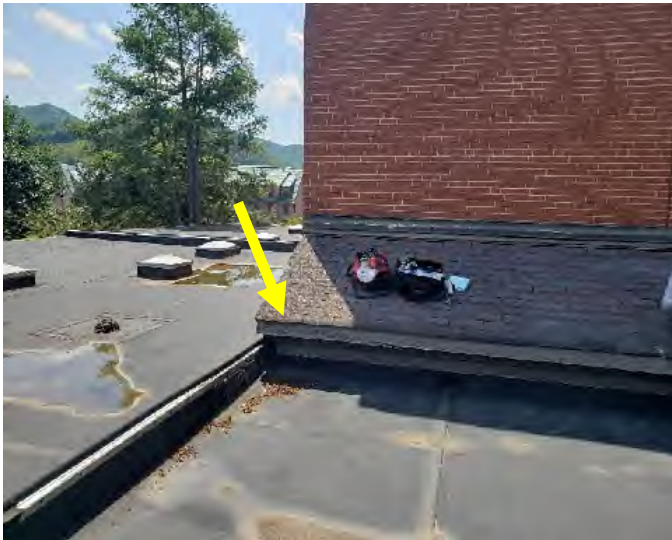
PHOTO No. 19

View of the Location for Asphalt Roof Shingles and Underlying Felt Paper **Sample WCRB-11 (C-11)** Obtained from South Side of Roof (Area) A4
(None Detected)

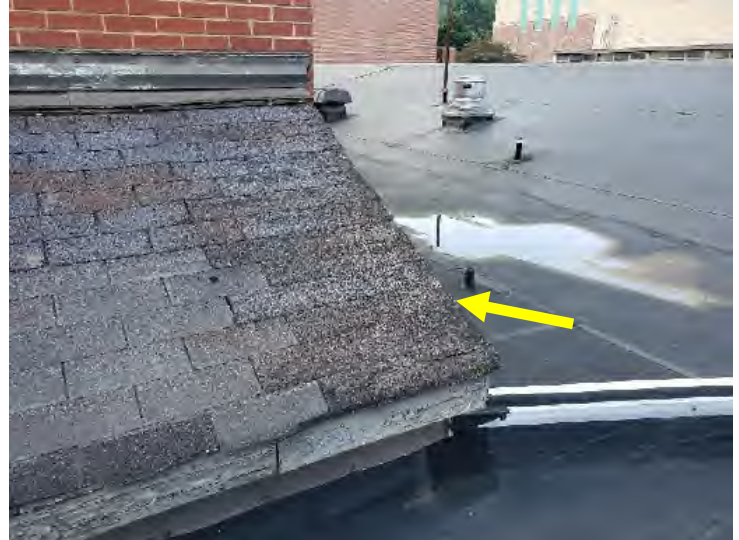
PHOTO No. 20

View of the Location for Asphalt Roof Shingles and Underlying Felt Paper **Sample WCRB-12 (C-12)** Obtained from North Side of Roof (Area) A4
(None Detected)

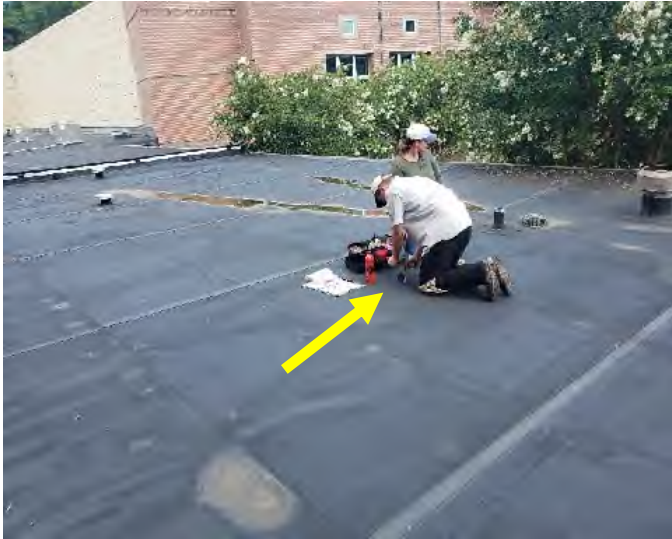
PHOTO No. 21

View of the Location for Roof Core **Sample WCRB-13**
(C-13) Obtained from Center of East Section of Roof (Area)
A2 (**None Detected**)

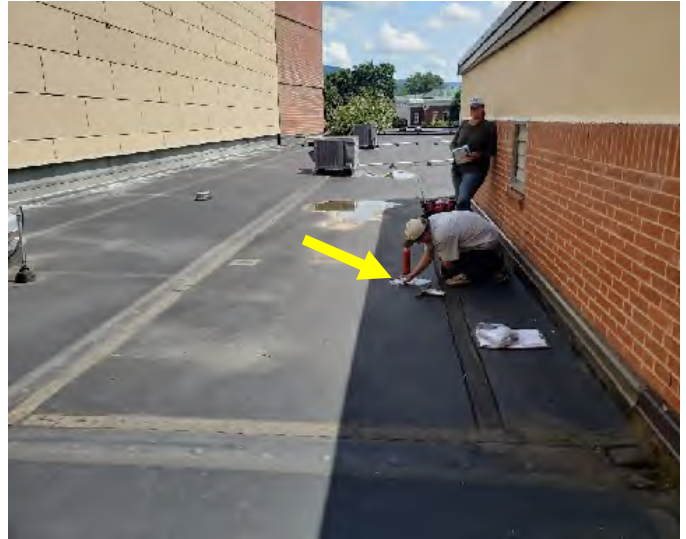
PHOTO No. 22

View of the Location for Roof Core **Sample WCRB-14**
(C-14) Obtained from Center of Roof (Area) B3
(**None Detected**)

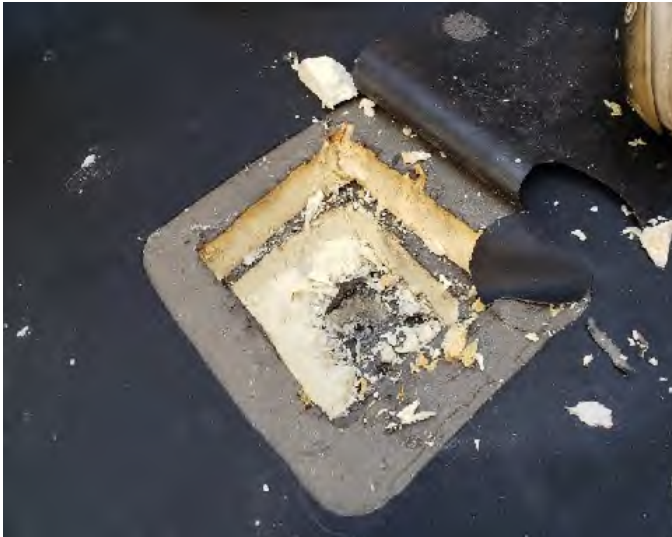
PHOTO No. 23

View of the Location for Roof Core **Sample WCRB-15**
(C-15) Obtained from Center of Roof (Area) U3
(**None Detected**)

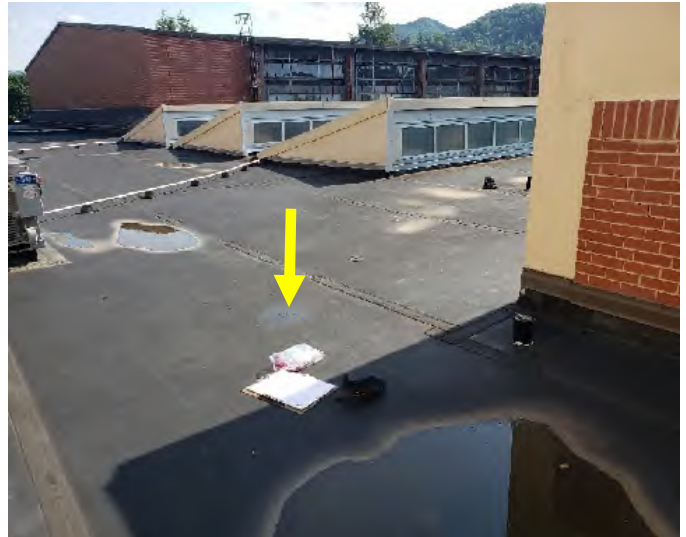
PHOTO No. 24

View of the Location for Roof Core **Sample WCRB-16**
(C-16) Obtained from Northeast Corner of Roof (Area) A2
(**None Detected**)

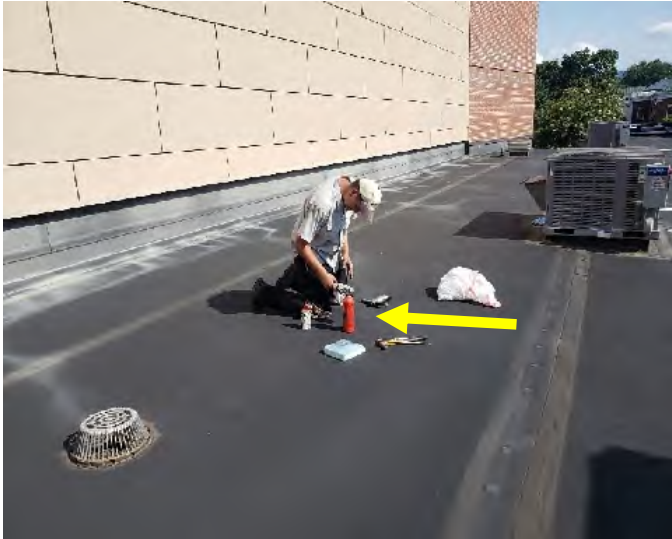
PHOTO No. 25

View of the Location for Roof Core **Sample WCRB-17**
(C-17) Obtained from Center of Roof (Area) F1
(None Detected)

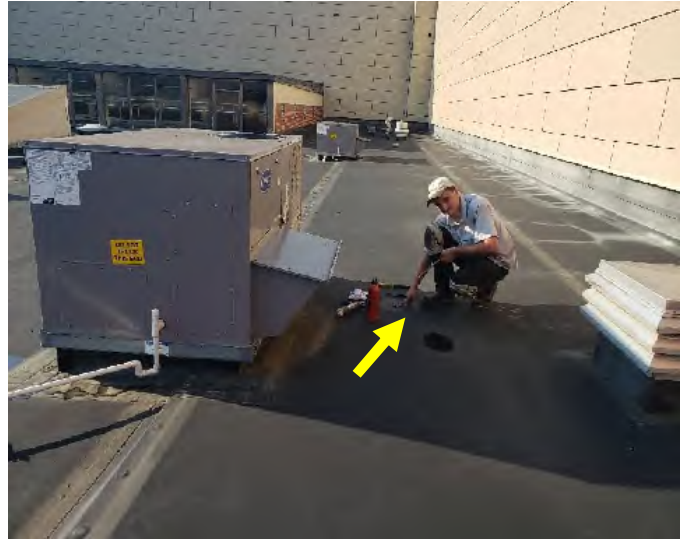
PHOTO No. 26

View of the Location for Roof Core **Sample WCRB-18**
(C-18) Obtained from South Side of Roof (Area) F1
(None Detected)

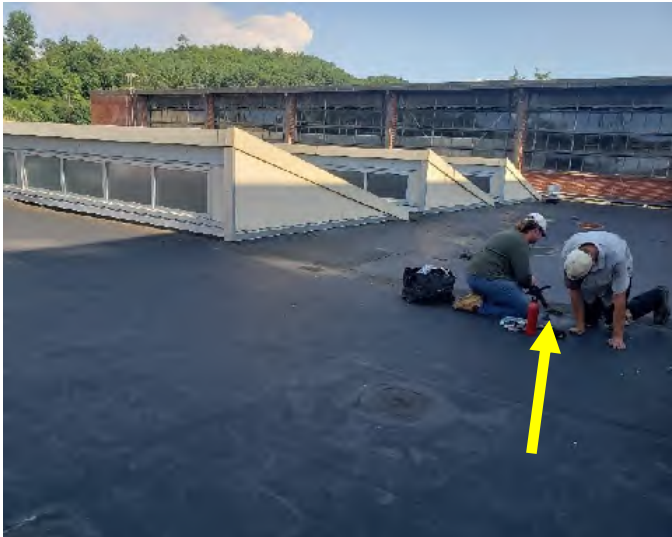
PHOTO No. 27

View of the Location for Roof Core **Sample WCRB-19**
(C-19) Obtained from Northwest Corner of Roof (Area) A2
(None Detected)

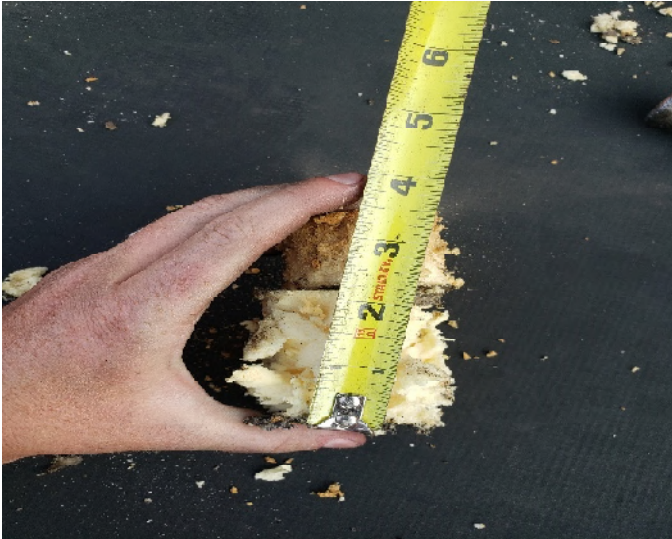
PHOTO No. 29

View of the Location for Roof Core **Sample WCRB-21**
(C-21) Obtained from South Side of Northern Section of
Roof (Area) A2 (**None Detected**)

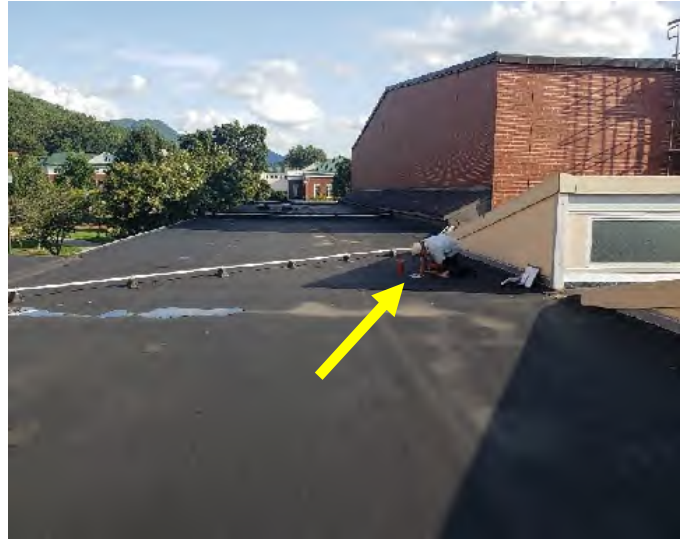
PHOTO No. 30

View of the Location for Roof Core **Sample WCRB-22**
(C-22) Obtained from East Side of Northern Section of Roof
(Area) A2 (**None Detected**)

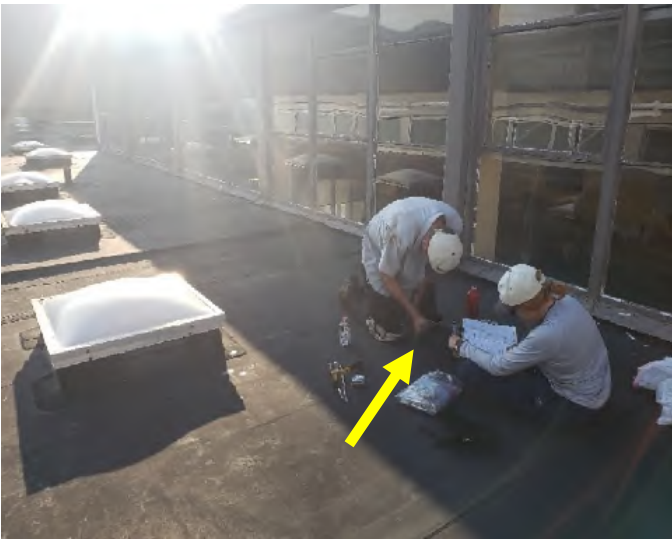
PHOTO No. 31

View of the Location for Roof Core **Sample WCRB-23**
(C-23) Obtained from North Side of Roof (Area) A2
(**None Detected**)

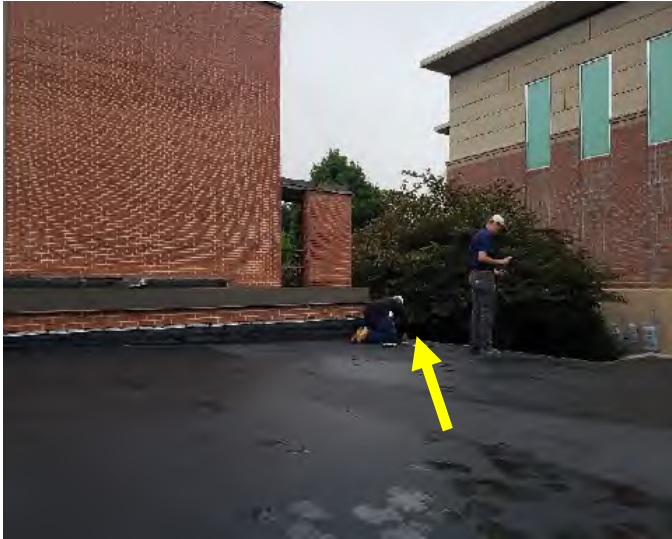
PHOTO No. 33

View of the Location for Roof Core **Sample WCRB-25**
(C-25) Obtained from Northwest Corner of Roof (Area) E1
(None Detected)

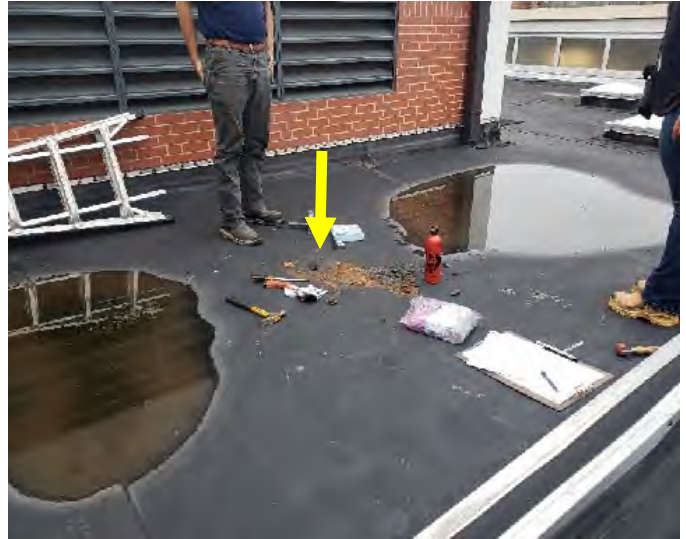
PHOTO No. 34

View of the Location for Roof Core **Sample WCRB-26**
(C-26) Obtained from Corner of Roof (Area) U2
(None Detected)

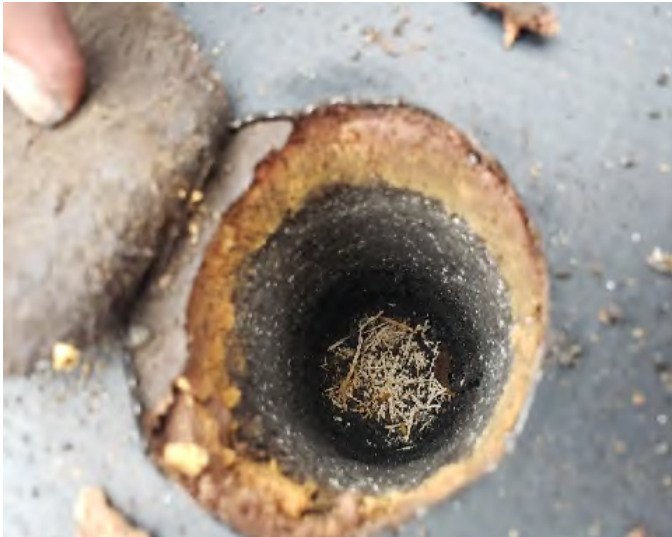
PHOTO No. 35

View of the Location for Roof Core **Sample WCRB-27**
(C-27) Obtained from North Side of Roof (Area) A2
(None Detected)

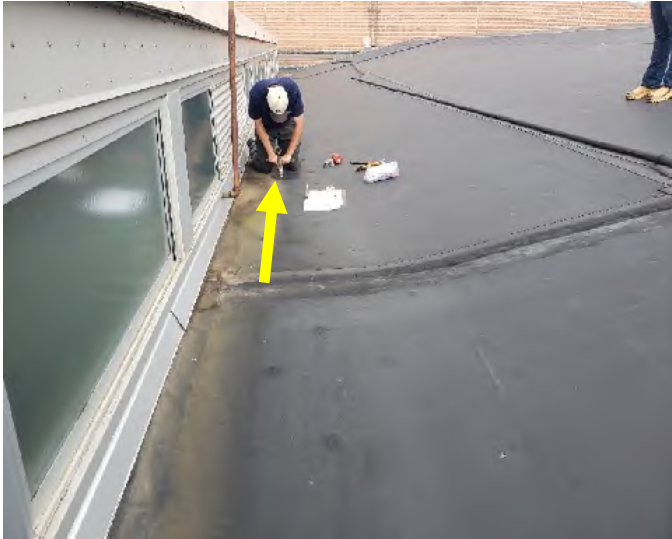
PHOTO No. 37

View of the Location for Roof Core **Sample WCRB-29**
(C-29) Obtained from Middle Section of Roof (Area) A3 –
Bottom of Slope (**None Detected**)

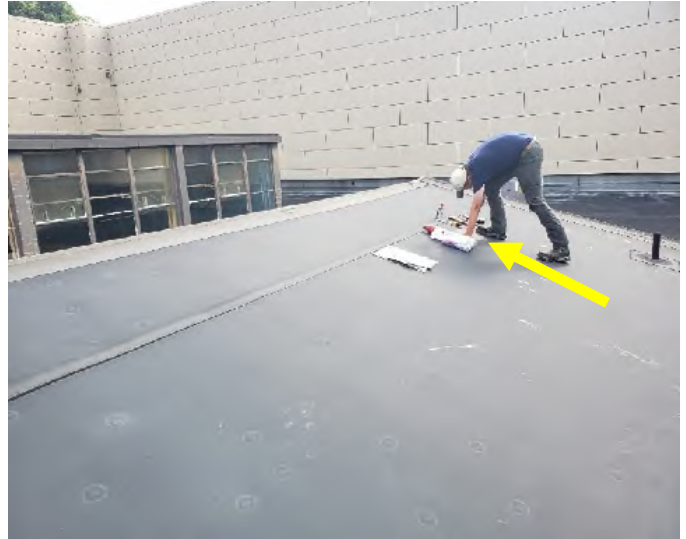
PHOTO No. 38

View of the Location for Roof Core **Sample WCRB-30**
(C-30) Obtained from Northeast Corner of Northern Section of
Roof (Area) A3 (**None Detected**)

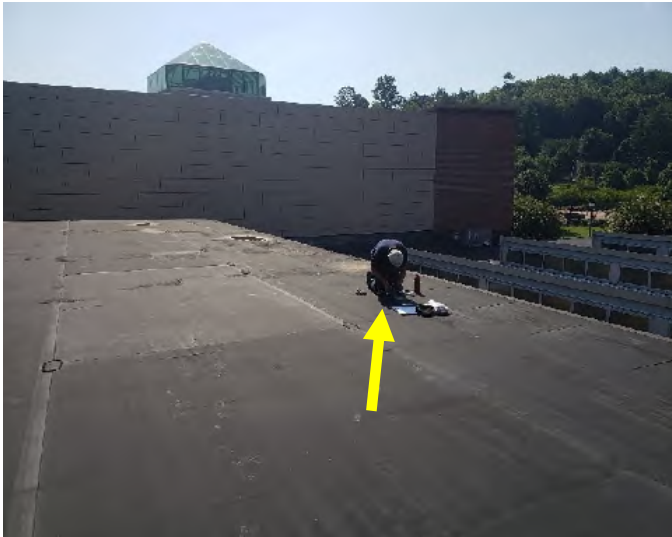
PHOTO No. 39

View of the Location for Roof Core **Sample WCRB-31**
(C-31) Obtained from South Central Side of Roof (Area) B1
(**None Detected**)

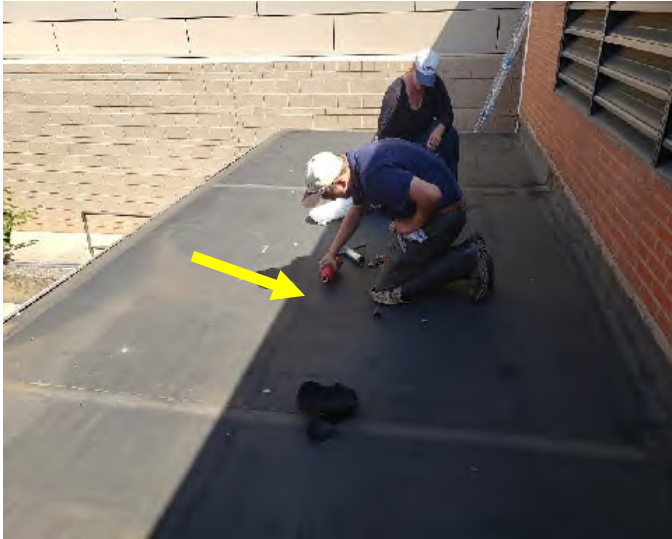
PHOTO No. 41

View of the Location for Roof Core **Sample WCRB-33**
(C-33) Obtained from Center of Roof (Area) U1
(None Detected)

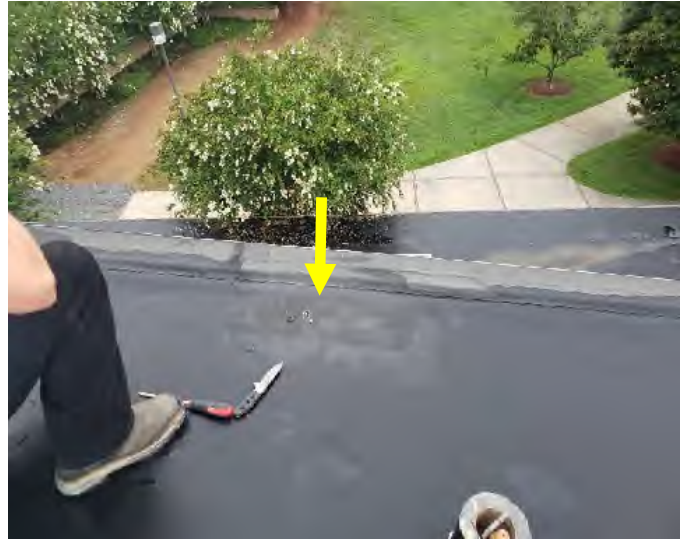
PHOTO No. 42

View of the Location for Roof Flashing **Sample WCRB-34**
(F-1) Obtained from East Side Perimeter of Roof (Area) A1
(None Detected)

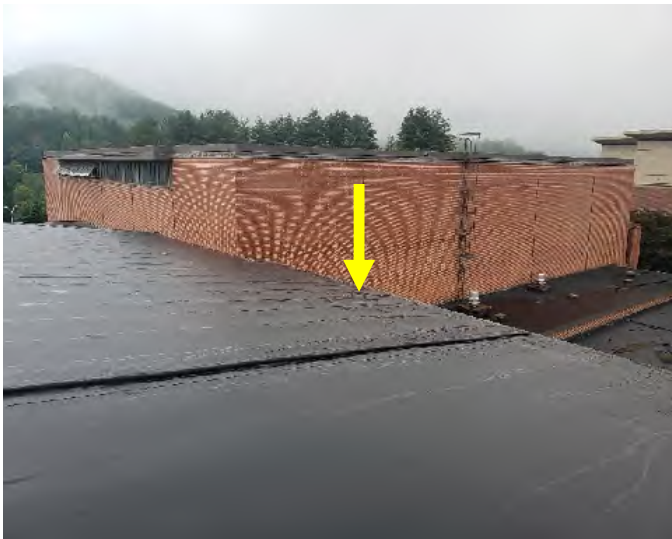
PHOTO No. 43

View of the Location for Roof Flashing **Sample WCRB-35**
(F-2) Obtained from North Side Perimeter of Roof (Area) A1
(None Detected)

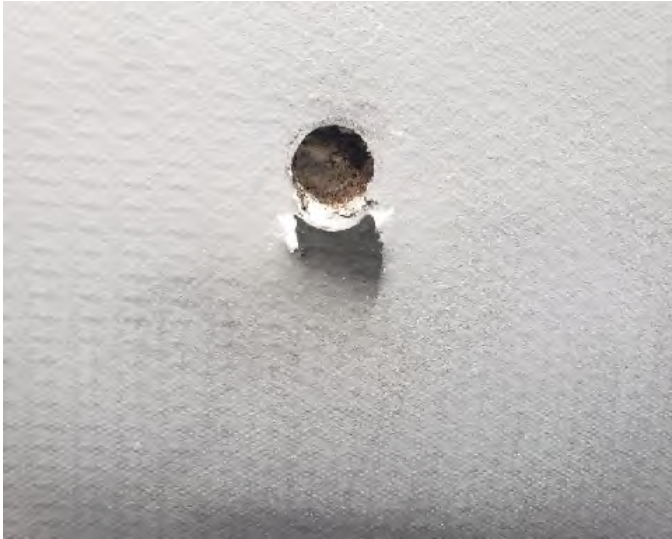
PHOTO No. 45

View of the Location for Roof Flashing **Sample WCRB-37**
(F-4) Obtained from West Side Perimeter of Roof (Area) D1
(4% Chrysotile Asbestos)

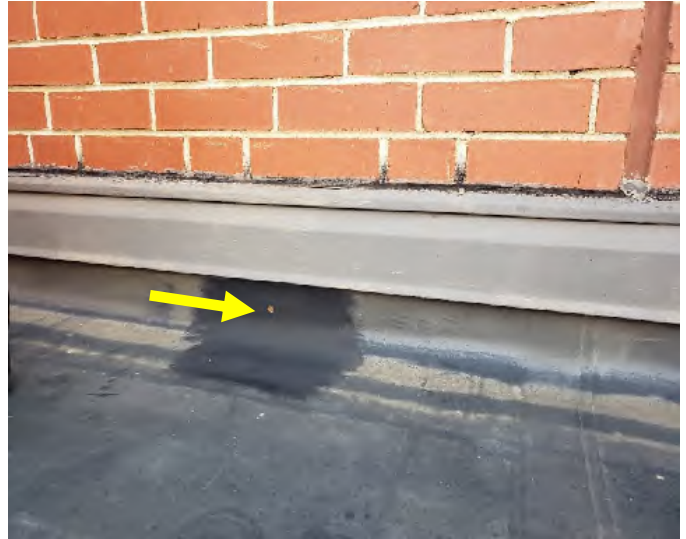
PHOTO No. 46

View of the Location for Roof Flashing **Sample WCRB-38**
(F-5) Obtained from East Side Perimeter of Roof (Area) U4
(None Detected)

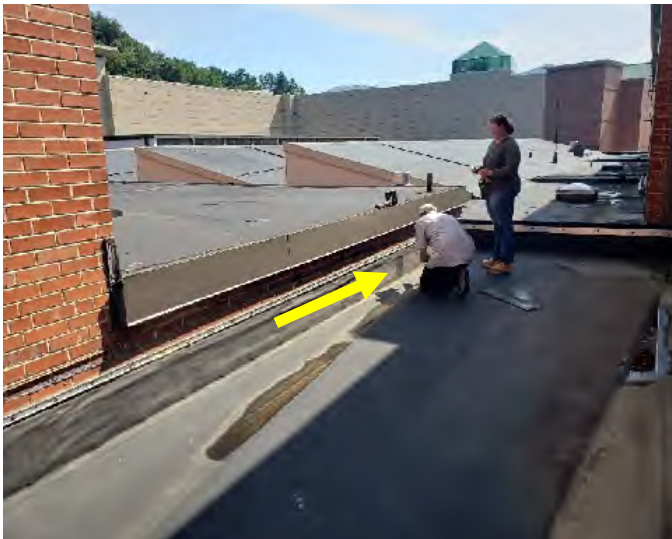
PHOTO No. 47

View of the Location for Roof Flashing **Sample WCRB-39**
(F-6) Obtained from North Side Perimeter of Roof (Area) C6
(None Detected)

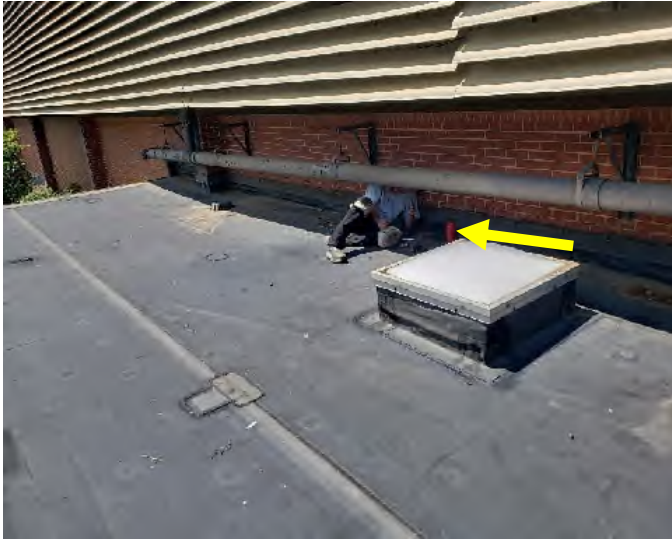
PHOTO No. 49

View of the Location for Roof Flashing **Sample WCRB-42**
(F-9) Obtained from North Side Perimeter of Southern
Section of Roof (Area) A2 (**None Detected**)

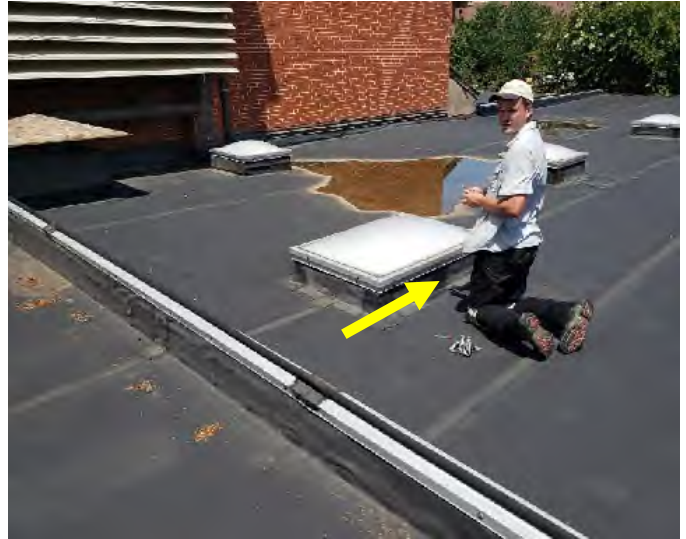
PHOTO No. 50

View of the Location for Roof Flashing **Sample WCRB-43**
(F-10) Obtained from Southeast Section Skylight in Roof
(Area) A2 (**None Detected**)

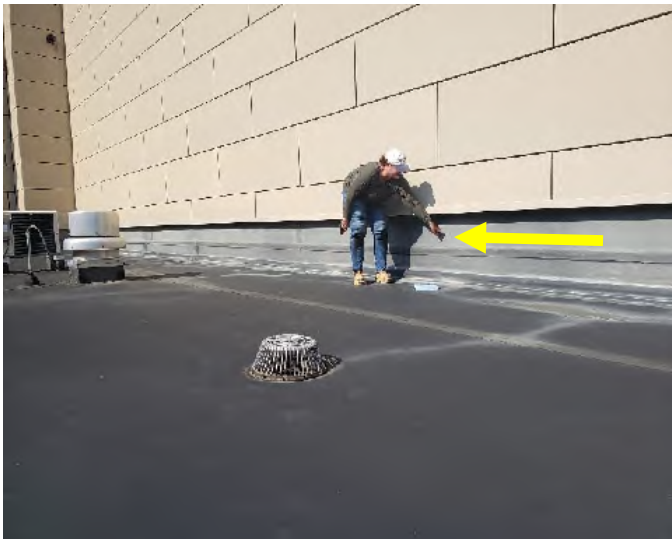
PHOTO No. 51

View of the Location for Roof Flashing **Sample WCRB-46**
(F-13) Obtained from East Side Perimeter of Roof (Area) F1
(**None Detected**)

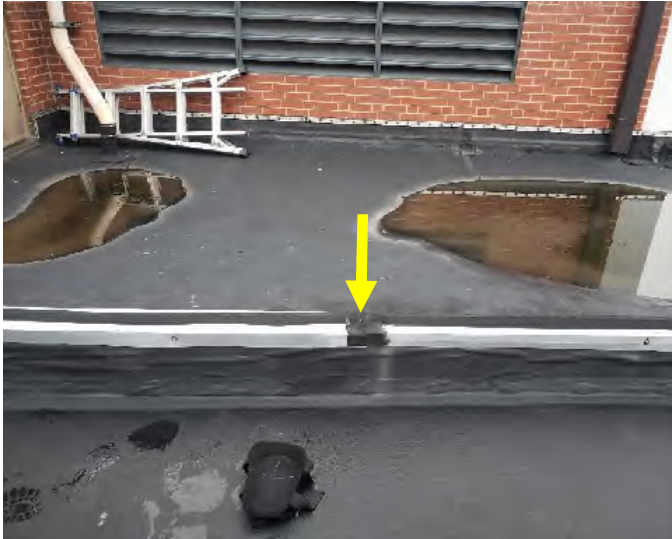
PHOTO No. 53

View of the Location for Roof Flashing **Sample WCRB-50 (F-17)** Obtained from East Side Perimeter of Roof (Area) E1
(None Detected)

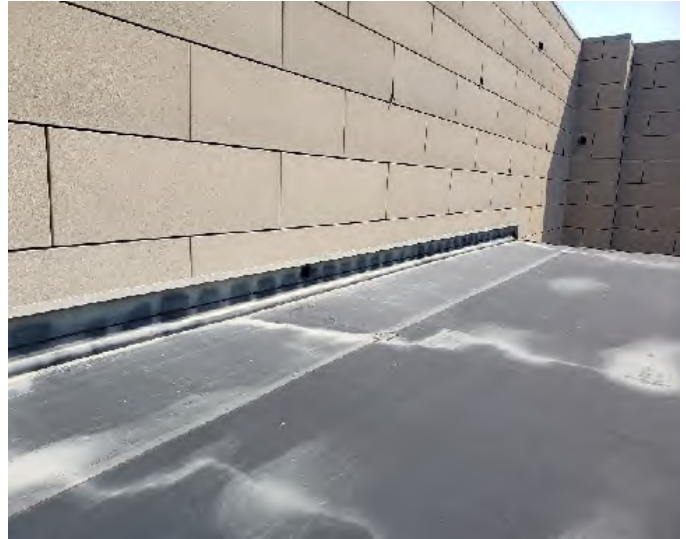
PHOTO No. 54

View of the Location for Roof Flashing **Sample WCRB-53 (F-20)** Obtained from North Side Perimeter of Roof (Area) B1
(None Detected)

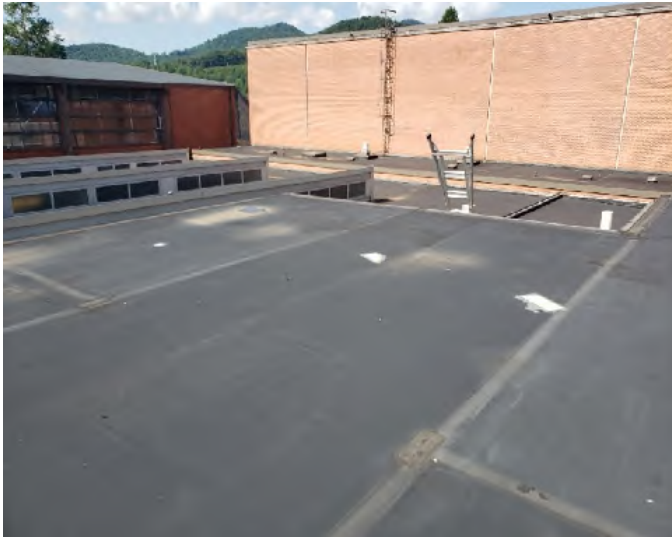
PHOTO No. 55

View of the Location for Roof Flashing **Sample WCRB-54 (F-21)** Obtained from West Side Perimeter of Roof (Area) B1
(None Detected)
