ADDENDUM TO
SPECIFICATIONS ENTITLED
"SPECIFICATIONS FOR
HFR BUILDING
65 WEST UNIVERSITY WAY
CULLOWHEE, NORTH CAROLINA 28723
ROOF REPLACEMENT PROJECT
SCO ID NO. 22-24898-01A"

ADDENDUM NO. 2

JUNE 16, 2023

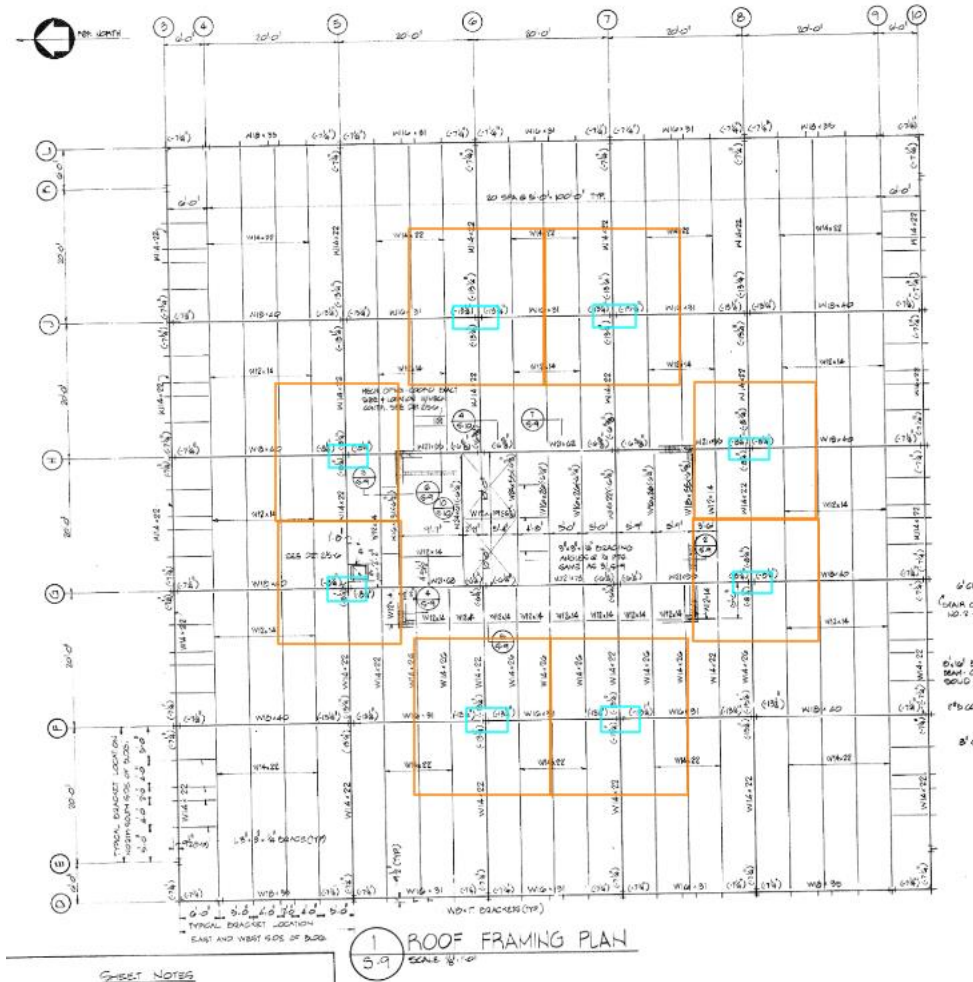
1. Can we use a roof top hoist to move material from the lower roof to the main roof. The lower roof being the one that is adjacent to the temp road .
 - a. *No roof top hoists can be used. However, a hoist/elevator system could be considered with the scaffolding erector and their engineers.*
2. How much material can we store on the upper roof spread out
 - a. *Contractor may load roof as follows. See Figure 1: Existing Framing Plan for reference:*
 - i. *Materials with a bearing pressure less than 12 lbs/sf may be placed anywhere.*
 - ii. *Materials exceeding a bearing pressure of 12 lbs/sf shall be placed over the existing columns (identified in light blue). Load directly over columns shall be limited to 4000 lbs with a maximum bearing area of 32sf. No additional materials may be stored within the tributary area of the column (orange rectangle)*

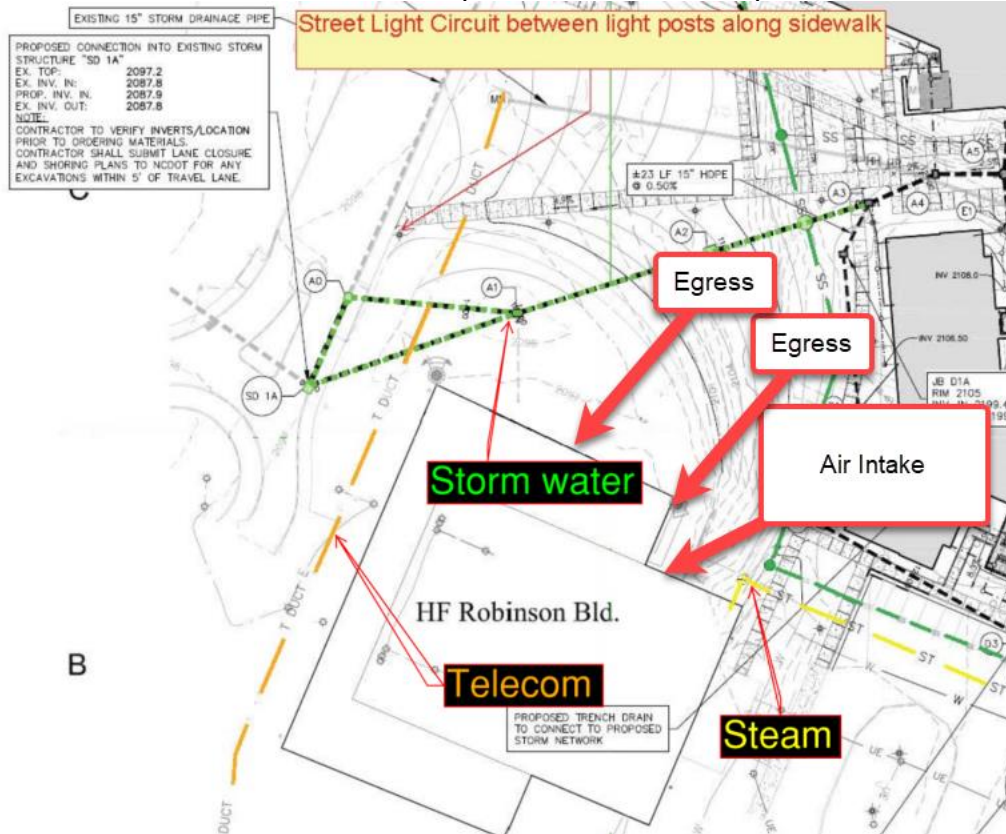
Figure 2: Locations of Utilities

6. The temp road fenced in area , can we have full use of that area for small Lay-down and equipment storage, along with dumpster use there.
 - a. *Yes, so long as both egress doors and pathways remain accessible at all times, utilities/buildng are not damaged and the large tree nearest the cooling tower is protected (Figure 2: Locations of Utilities). Contractor is responsible restoring the*

grounds as required in the project documents. Stair tower within this area shall be wrapped in fabric to catch falling debris. The air intake below the location of the stair tower will need to be protected from debris, particulates, and odors.

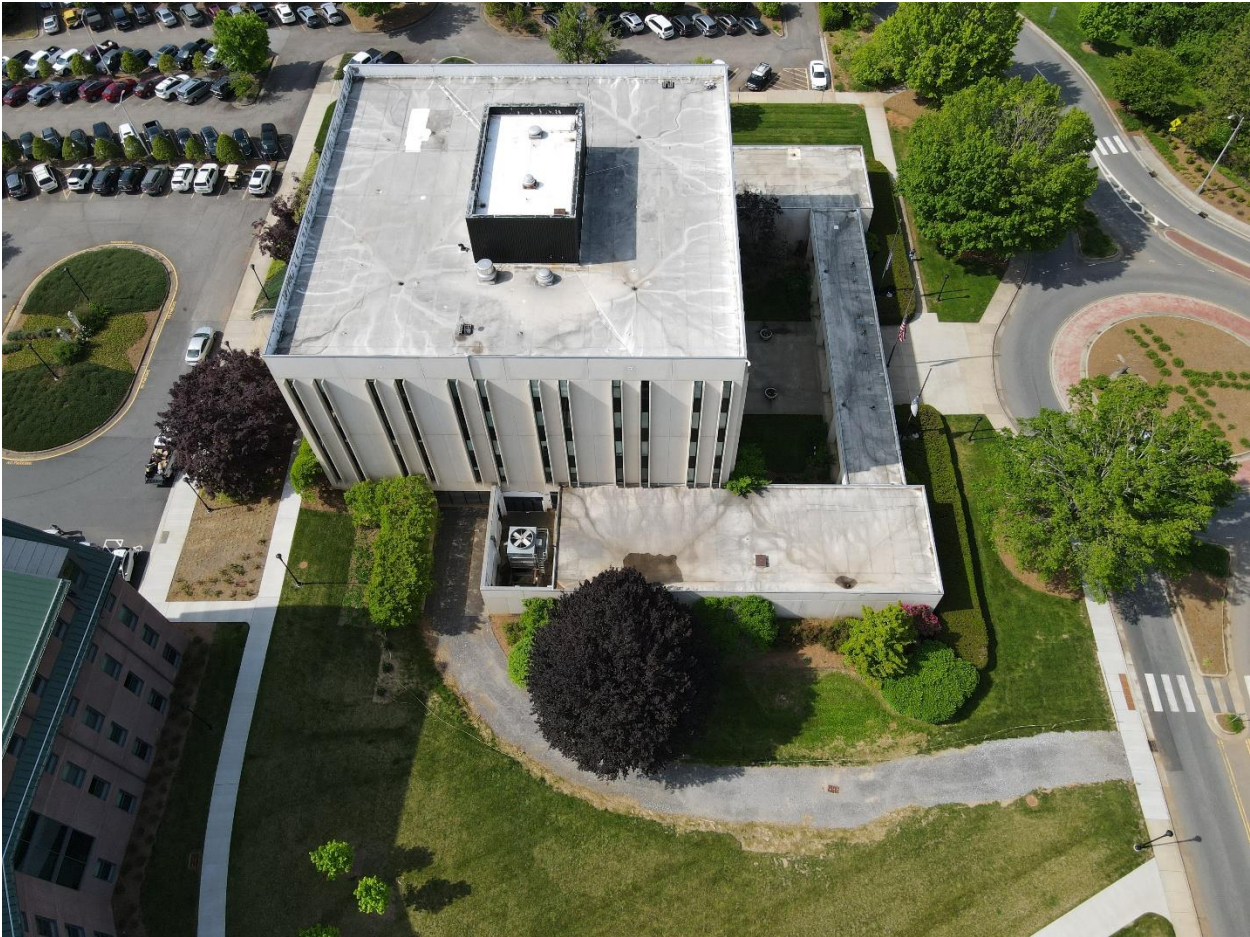
Figure 3

- a. *The surface of the precast concrete panels has an exposed aggregate finish. We do not believe surface mounted counter flashing will be appropriate in this situation. Install raggle type counterflashing as specified in 076200.3.2.*
23. Would you please send all Photos of the Roof Areas that are available?
- a. *See the attached photo log as well as Figure 3, Figure 4, Figure 5, and Figure 6. These photos are for information purposes only. It is the Contractors responsibility to confirm the existing conditions.*
