Project: Specifications for UNC MEMORIAL HALL
114 E CAMERON AVE
CHAPEL HILL, NORTH CAROLINA 27514
ROOF REPLACEMENT PROJECT
SCO ID NO. 22-25151-01A

ADDENDUM NO. 1

LIMITED ASBESTOS INSPECTION REPORT
UNIVERSITY OF NORTH CAROLINA AT CHAPEL HILL
MEMORIAL HALL – ROOFS
114 E CAMERON AVE, CHAPEL HILL, NORTH CAROLINA 27514
Terracon Project No. FJ226041
November 30, 2022

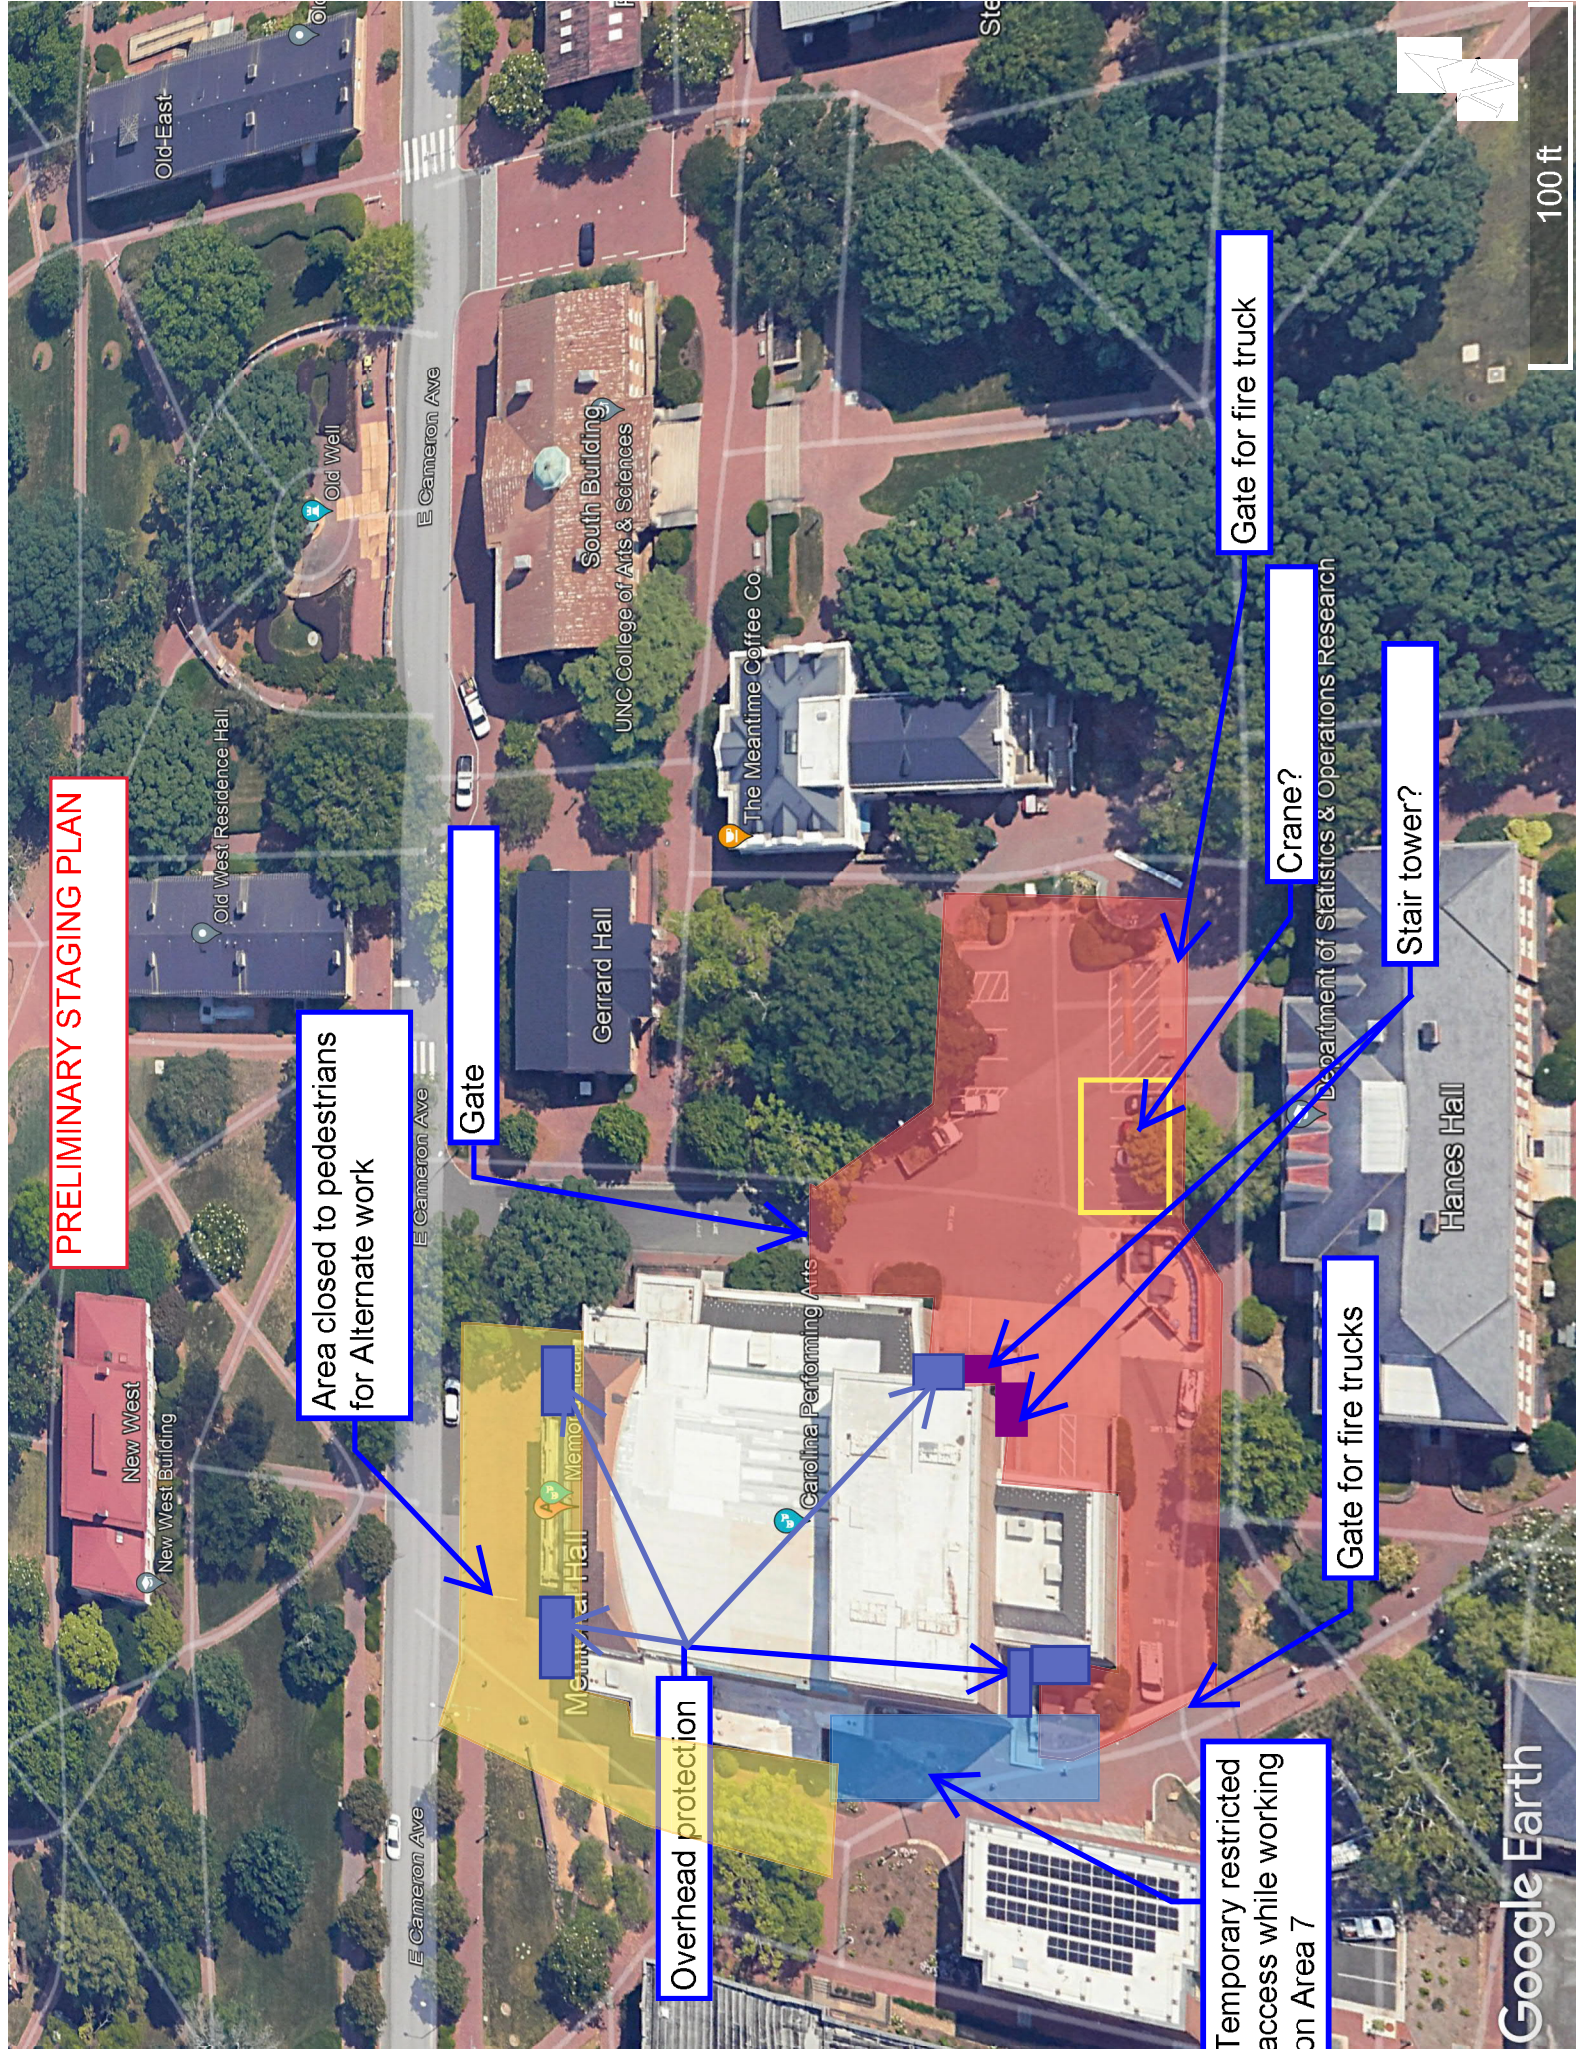
PRELIMINARY STAGING PLAN

Area closed to pedestrians for Alternate work

Overhead protection

Temporary restricted access while working on Area 7

Gate for fire truck

1. Refer to attached "PRELIMINARY STAGING PLAN" aerial image.
2. The Pre-bid meeting minutes are hereby incorporated into this Addendum.

4. Copies of a preliminary staging plan was distributed, prior to walking the ground level areas of the site and discussing potential staging issues, scaffolding, and potential fencing requirements.

- a. The contractors were reminded that the parking lot between Memorial Hall and Hanes Hall is the Fire Lane for multiple buildings in the area. Double width gates will be required at these locations to accommodate access for emergency vehicles.

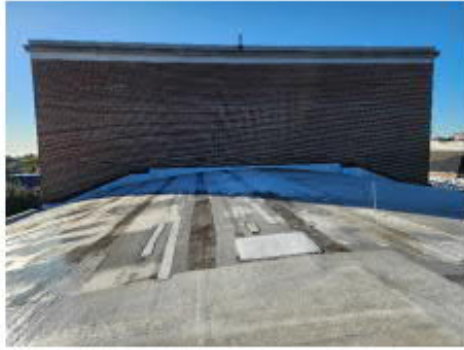
Photo #1 Barrel Roof and High Building on south side (Roof 1)

- **Roof 1:** The main roof is a barrel roof, consisting of a fully adhered single-ply Thermoplastic Polyolefin (TPO) membrane roofing system, on top of 2" Pyrobar gypsum plank deck, with two layers of polyisocyanurate insulation.

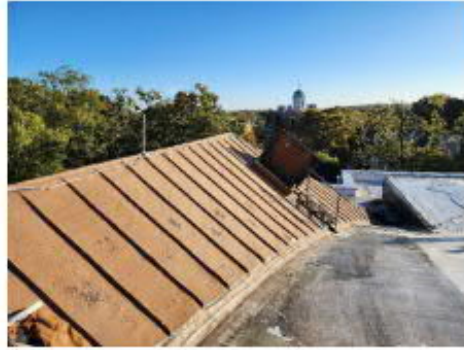
Photo #2 Metal Roof (Roof A) at the Barrel Roof north side (Roof 1)

- **Roof A:** This roof is a standing seam metal roof over built-up roofing base sheet and Pyrobar gypsum plank deck, without any insulation observed. The top of the pitched metal roof appears to be flat, with no slope.

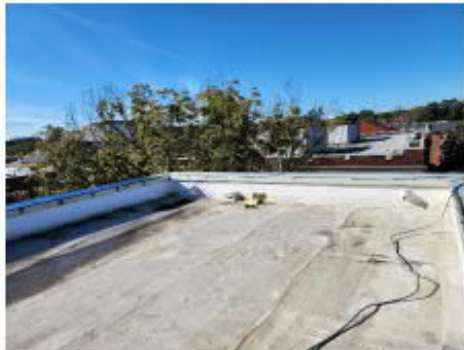
Photo #3 Lower NW Flat Roof (Roof 3)

- **Roof 3 and 4:** These lower side roofs, located at the northeast and northwest sides of the Memorial Hall, consist in a fully adhered single-ply TPO membrane roofing system on top of a concrete substrate, with two layers of polyisocyanurate insulation.

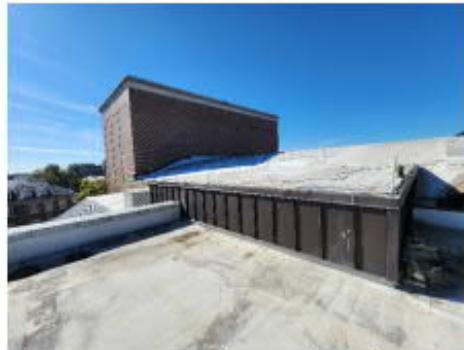
Photo #4 Upper and Lower Flat Roofs on NE side (Roofs 2 and 4)

- **Roof 2:** Located on the northeast side of the building, it consists of a fully adhered single-ply TPO membrane roofing system, on top of metal decking. Insulation includes two layers of polyisocyanurate.

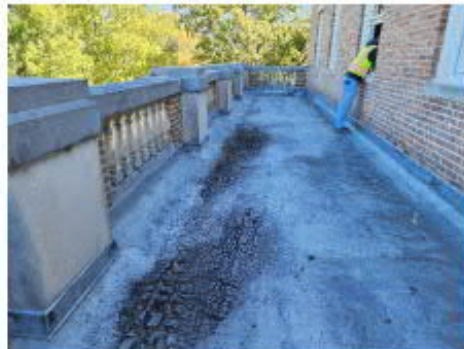
Photo #5 North Porte-Cochere Roof with Balustrade (Roof 9)

- **Roof 9:** The porte-cochere roof, located on the north side of the building, consists of an asphaltic layer applied over plywood substrate, mounted on wooden support beams, itself attached to a concrete substrate. The balcony also includes a stone balustrade.

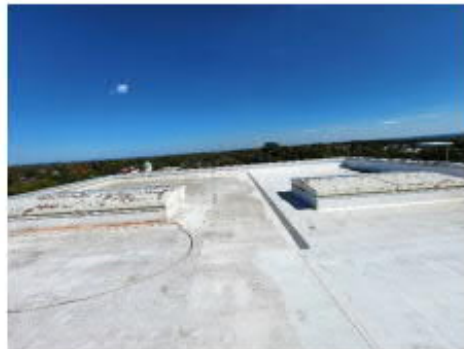
Photo #6 High Building Roof (Roof 7)

- **Roof 7:** The high roof is a low slope, single-ply TPO membrane roof system, with roughly two layers of tapered polyisocyanurate insulation. This insulation is adhered to the concrete substrate.

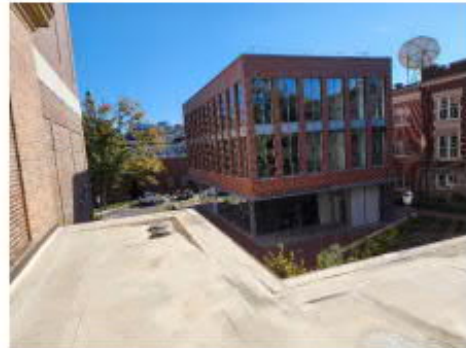
Photo #8 Low Roof between the Memorial Hall and the Curtis Media Building (Roof 6)

- **Roof 6:** This lower roof, located between the Memorial Hall and the Curtis Media Building, consists in a low slope, single-ply TPO membrane roof system, with roughly 5.5 inches of tapered polyisocyanurate insulation, over wooden deck.

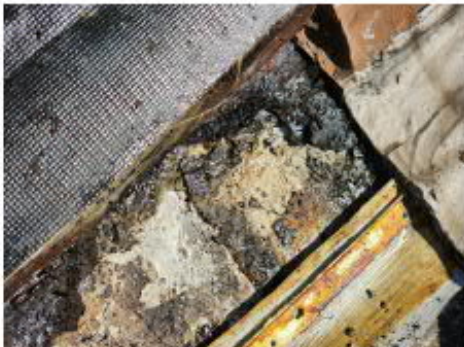
Photo #9 Asbestos-containing Black Tar Paper at the North Metal Roof A (HA #6)

The above identified asbestos-containing materials are considered NESHAP Category I non-friable ACM. The materials were observed in good condition. Terracon recommends this material be removed by a state of North Carolina licensed asbestos abatement contractor prior to roof replacement activities.

HA	Material Description	Material Location	Percent / Type Asbestos	NESHAP Classification	Condition	Estimated Quantity ¹
6	Black Tar Paper	North Metal Roof (Roof A)	45% Chrysotile	Category I Non-Friable	Good	3,400 SF
14	Black Parapet Material	Parapet between Lower Flat Roofs and Barnet Roof (Roofs 1, 2, 3, and 4)	5% Chrysotile	Category I Non-Friable	Good	450 SF
21	White Caulk on Balustrade	North Front Balcony / Porte-Cochere Roof (Roof 9)	15% Chrysotile	Category I Non-Friable	Good	150 SF
24	Black Tar Paper/Material underneath Plywood	North Front Balcony / Porte-Cochere Roof (Roof 9)	45% Chrysotile	Category I Non-Friable	Good	550 SF

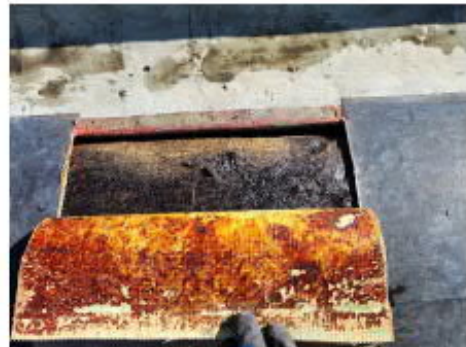
Photo #10 Asbestos-containing Black Material at the Parapet surrounding the Barrel Roof 1 (HA #14)

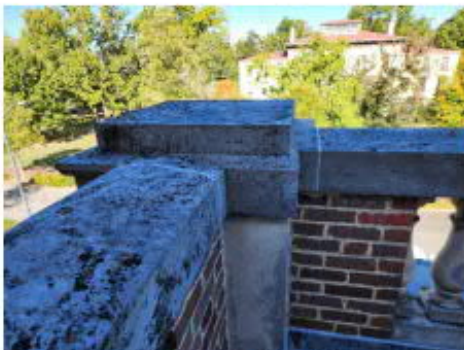
Photo #11 Asbestos-containing White Caulk on Balustrade at the North Porte-Cochere Roof 9 (HA #21)

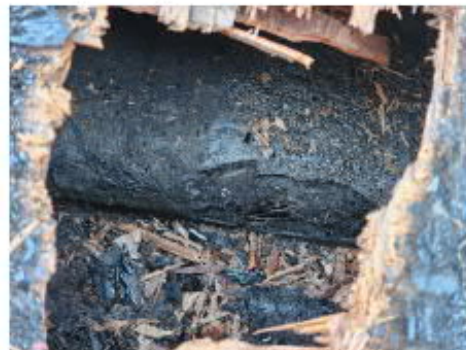
Photo #12 Asbestos-containing Black Tar Paper/Material underneath Plywood at the North Porte-Cochere Roof 5 (HA #24)
