ADDENDUM NO. 01

PROJECT: **WCU Reid Building Roof Replacement**
Western Carolina University, Cullowhee, NC
SCO ID#: 22-24547-01A
Atlas Engineering Job No. J2626

REPORT SUMMARIZING ROOF MATERIALS BULK SAMPLING ANALYSIS RESULTS TO DETERMINE ASBESTOS CONTENT

**WESTERN CAROLINA UNIVERSITY
REID HEALTH AND HUMAN PERFORMANCE BUILDING
ROOF SYSTEMS REPLACEMENT PROJECT
MEMORIAL AND CULLOWHEE DRIVES
CULLOWHEE, NORTH CAROLINA 28723
PROJECT NO.: OLME-2022-18**

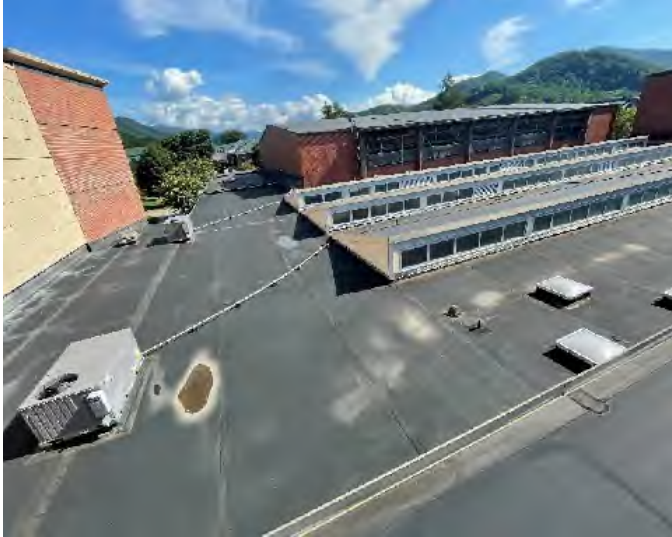
PHOTO No. 1

Roof Overview Displaying Portions of Roofs A1, A2 and A3

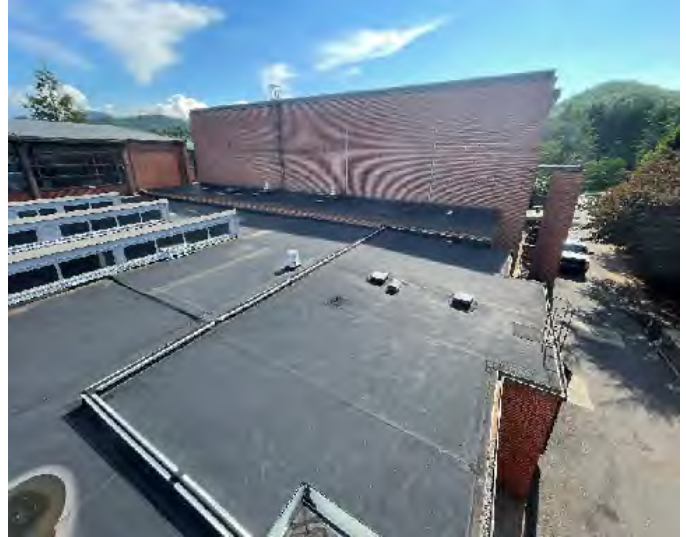
PHOTO No. 2

Roof Overview Displaying Portions of Roofs A2, A3 and E1

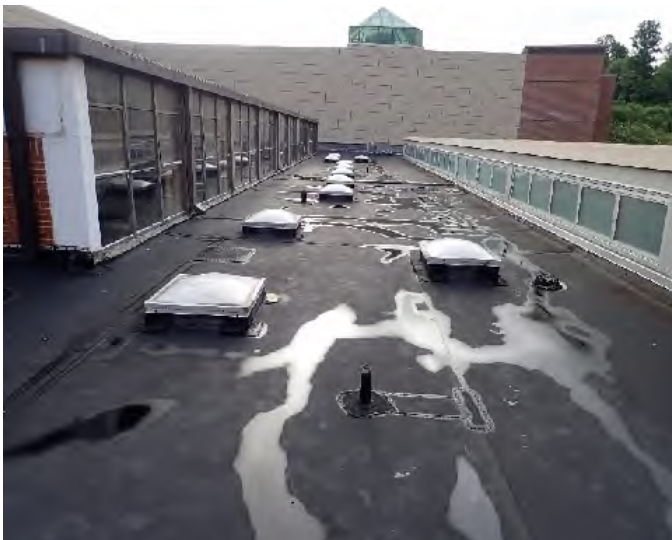
PHOTO No. 3

Overview Displaying Portion of Roof A2
Between Roofs A3 and B1

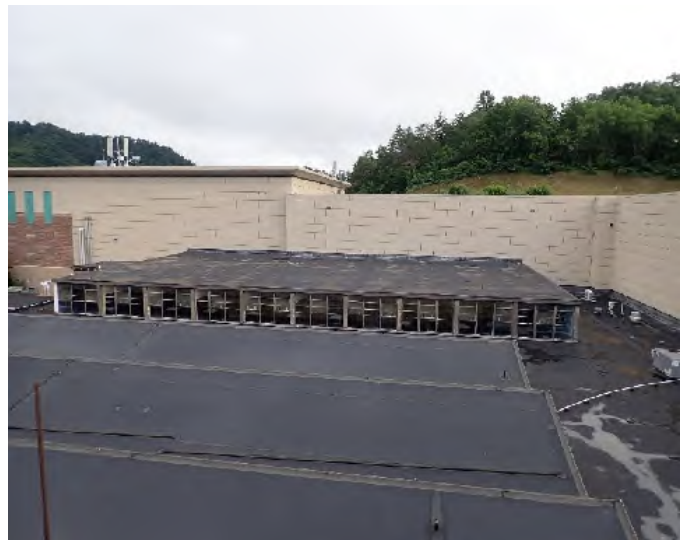
PHOTO No. 4

Overview Displaying Portions of Roofs B1, U1, U2 and U3

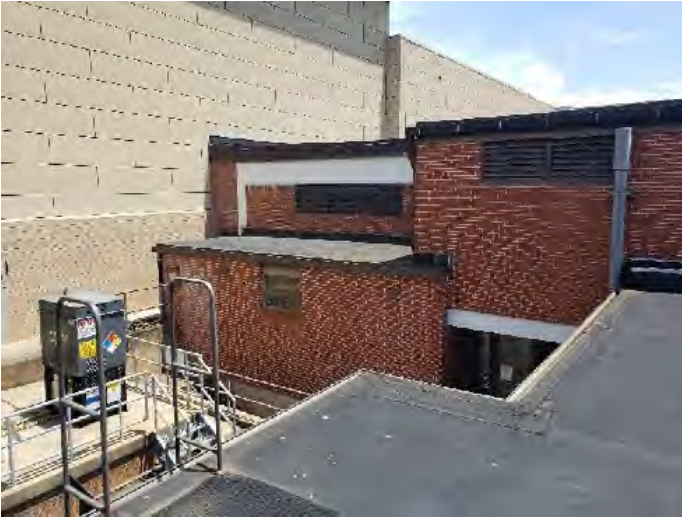
PHOTO No. 5
View Displaying Roof U1

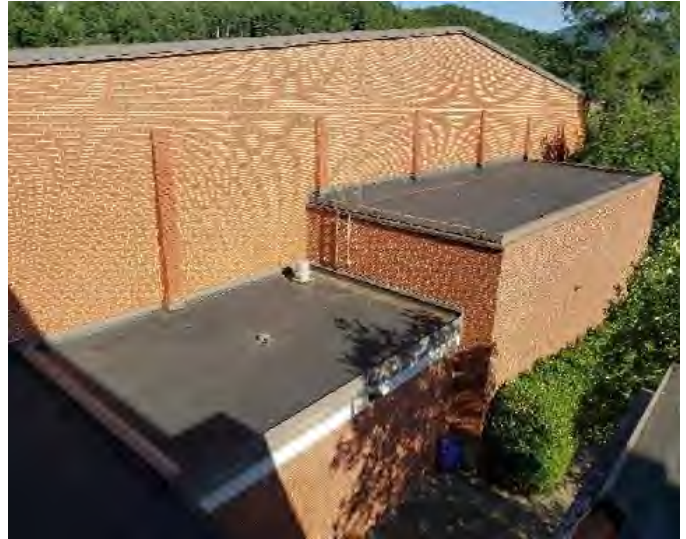
PHOTO No. 6
Overview Displaying Roofs D1 and U4

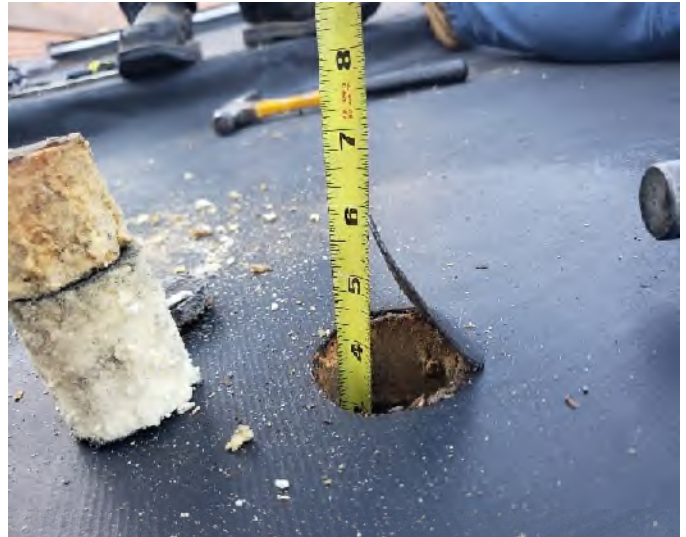
PHOTO No. 28

View of the Location for Roof Core **Sample WCRB-20**
(C-20) Obtained from West Side of Roof (Area) A2
(None Detected)

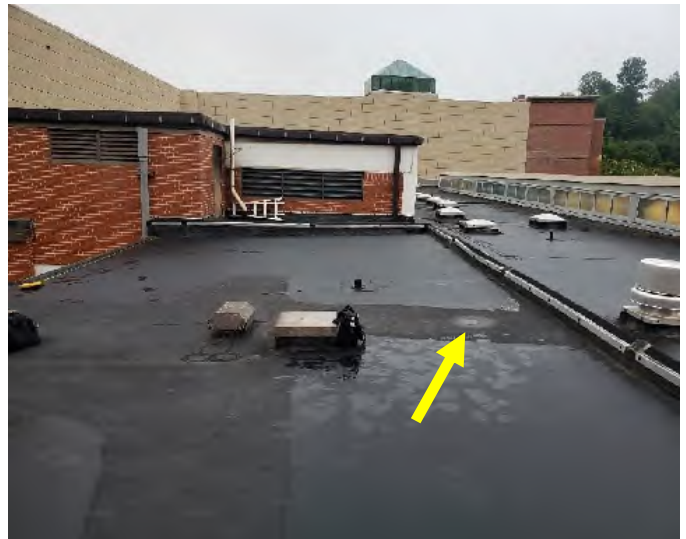
PHOTO No. 32

View of the Location for Roof Core **Sample WCRB-24**
(C-24) Obtained from South Side of Roof (Area) E1
(**None Detected**)

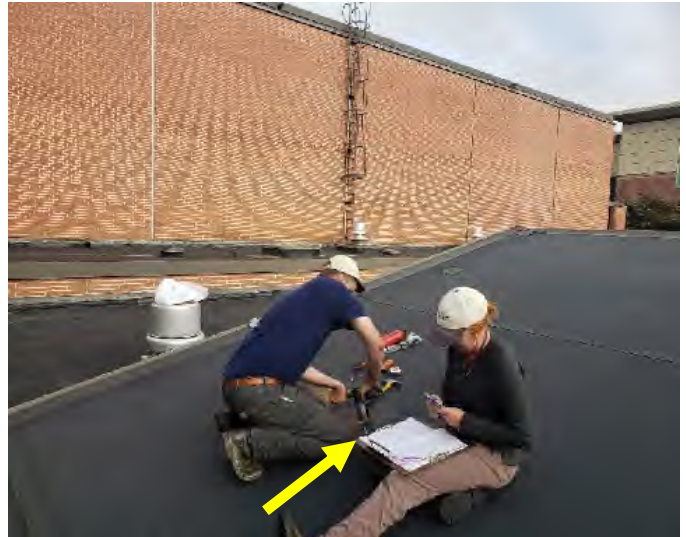
PHOTO No. 36

View of the Location for Roof Core **Sample WCRB-28**
(C-28) Obtained from Southwest Corner of Southern Section of
Roof (Area) A3 **(None Detected)**

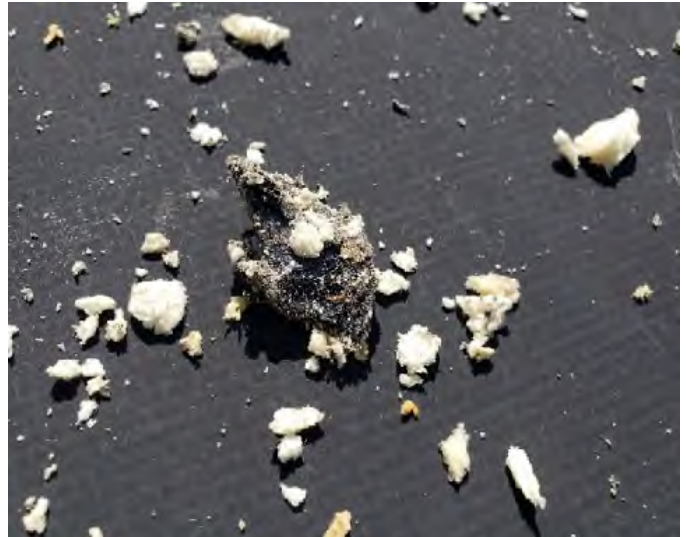
PHOTO No. 40

View of the Contents for Roof Core **Sample WCRB-32**
(C-32) Obtained from Southeast Side of Roof (Area) B1
(**None Detected**)

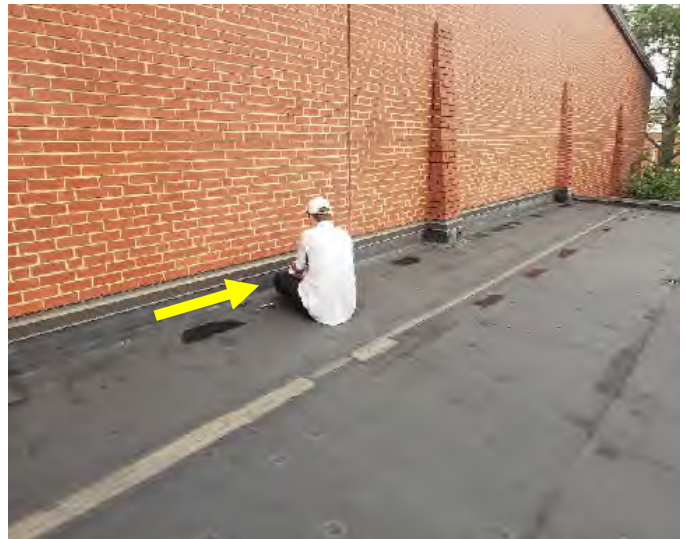
PHOTO No. 44

View of the Location for Roof Flashing **Sample WCRB-36**
(F-3) Obtained from East Side Perimeter of Roof (Area) D1
(None Detected)

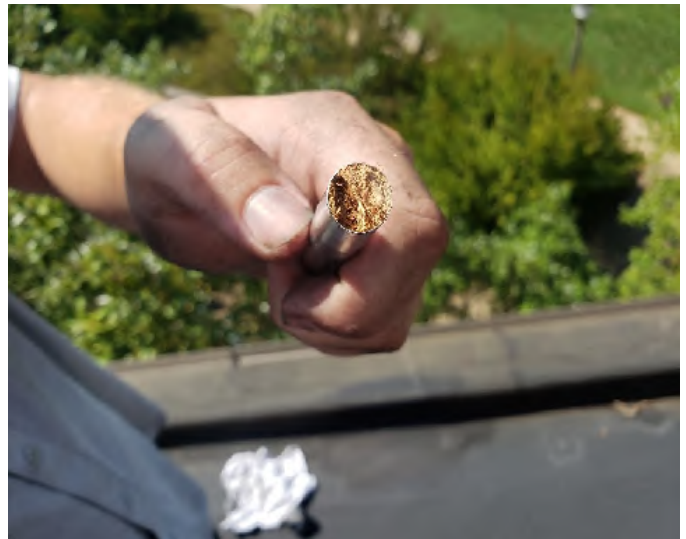
PHOTO No. 48

The black mastic layer contained in Area D1 roof core samples; roof flashing black bituminous vapor barrier throughout Roof Areas A2, C2 and D1; and gray infill at pilaster downspouts throughout Roof Area A2 are considered to be non-friable materials and were observed to be in fair to good condition. Damage(s) were generally observed due to age and weather-related deterioration due to exposure.

View of the Location for Roof Flashing **Sample WCRB-40**
(F-7) Obtained from South Side Perimeter of Roof (Area) C2
(5% Chrysotile Asbestos)

If the planned roof replacement activities include disturbing the identified non-friable ACMs, then these materials must be addressed in accordance with applicable Federal, State, and local regulations.

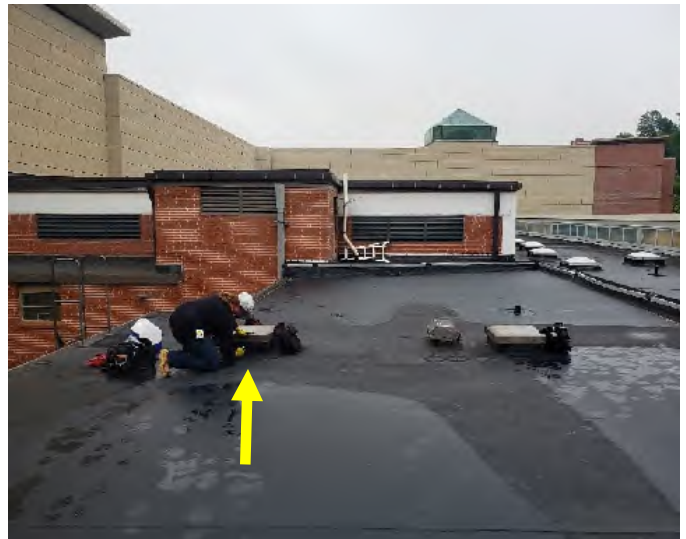
PHOTO No. 52

View of the Location for Roof Flashing **Sample WCRB-49**
(F-16) Obtained from Curb Penetration on Roof (Area) E1
(**None Detected**)

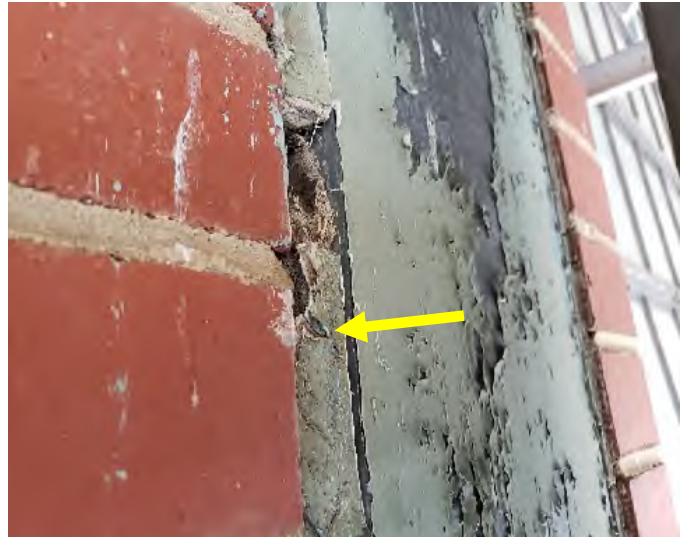
PHOTO No. 56

View of the Location for Infill at Pilaster Downspout **Sample WCRB-56 (S-1)** Obtained from North Side Perimeter of Southern Section of Roof (Area) A2
(4% Chrysotile Asbestos)
