# HYDE CORRECTIONAL INSTITUTION - ROOF REPAIRS

## NC DEPARTMENT OF ADULT CORRECTION

### SWAN QUARTER, NORTH CAROLINA

#### SCO ID#: 23-26754-01A

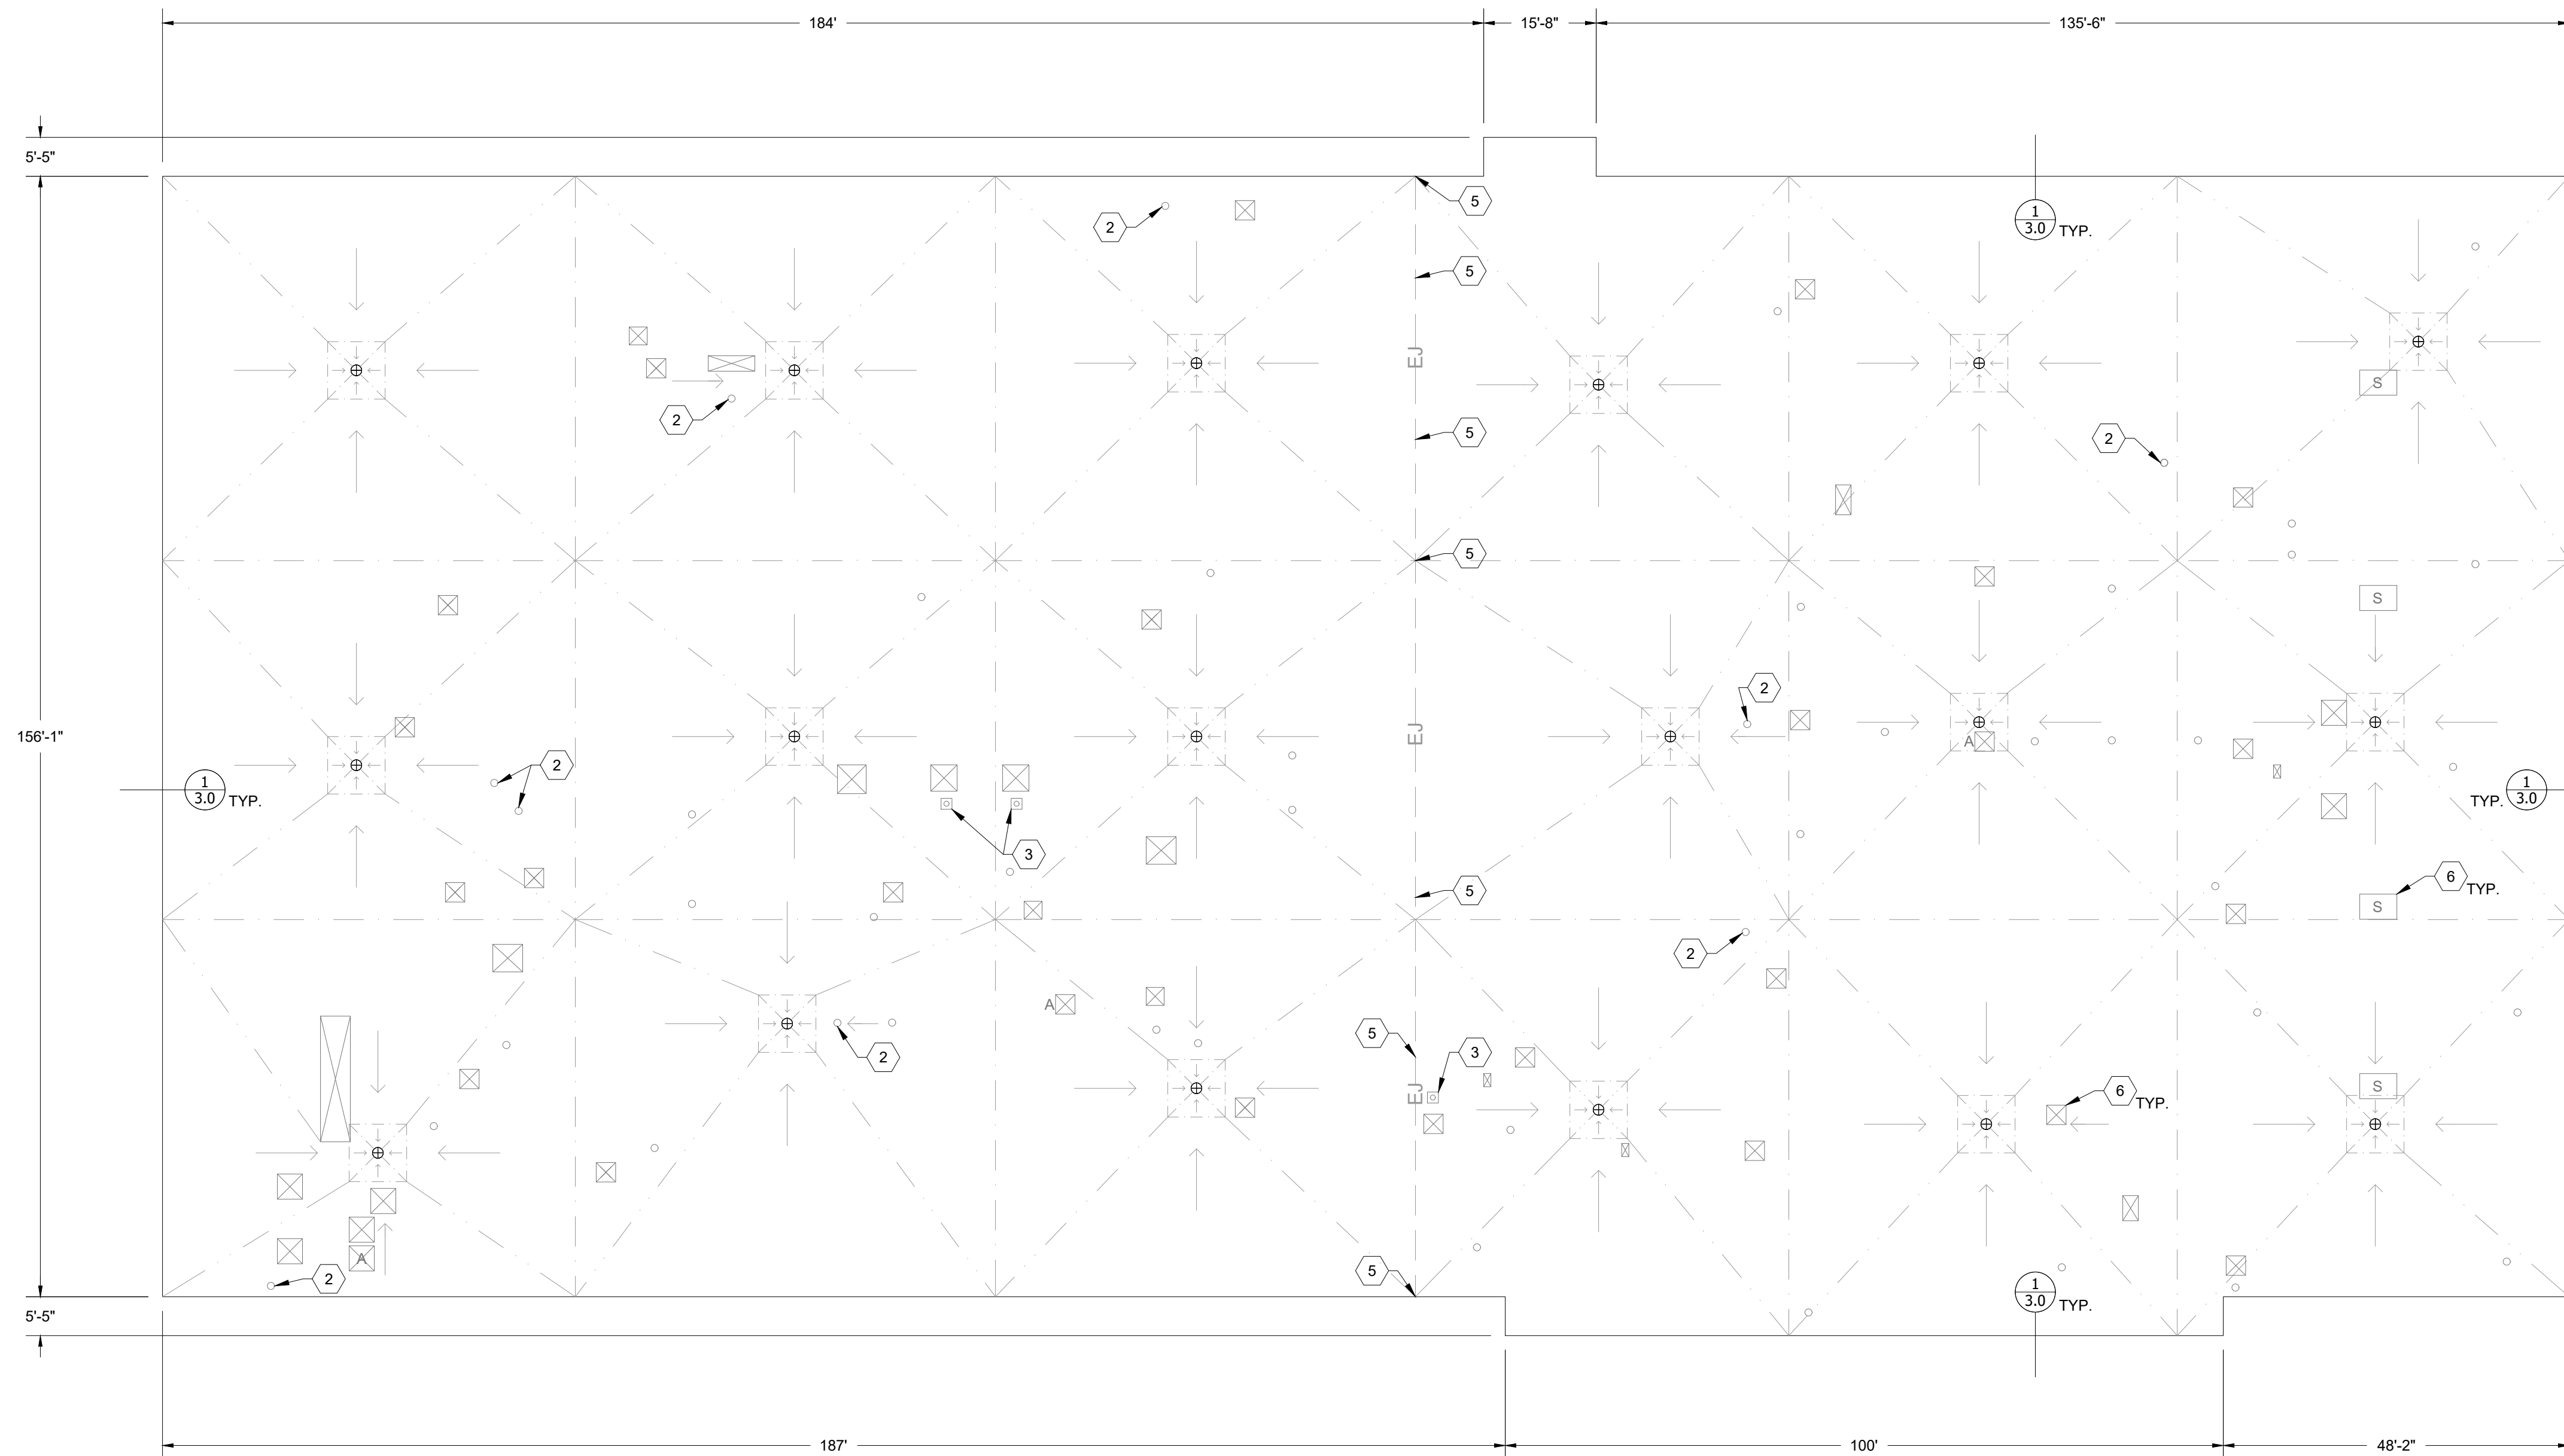
1 ADMIN BUILDING  
 2.0 SCALE: 1/16" = 1'-0"

NOTE:  
 6 - ALL EXISTING MECHANICAL UNITS/SKYLIGHT PENETRATIONS

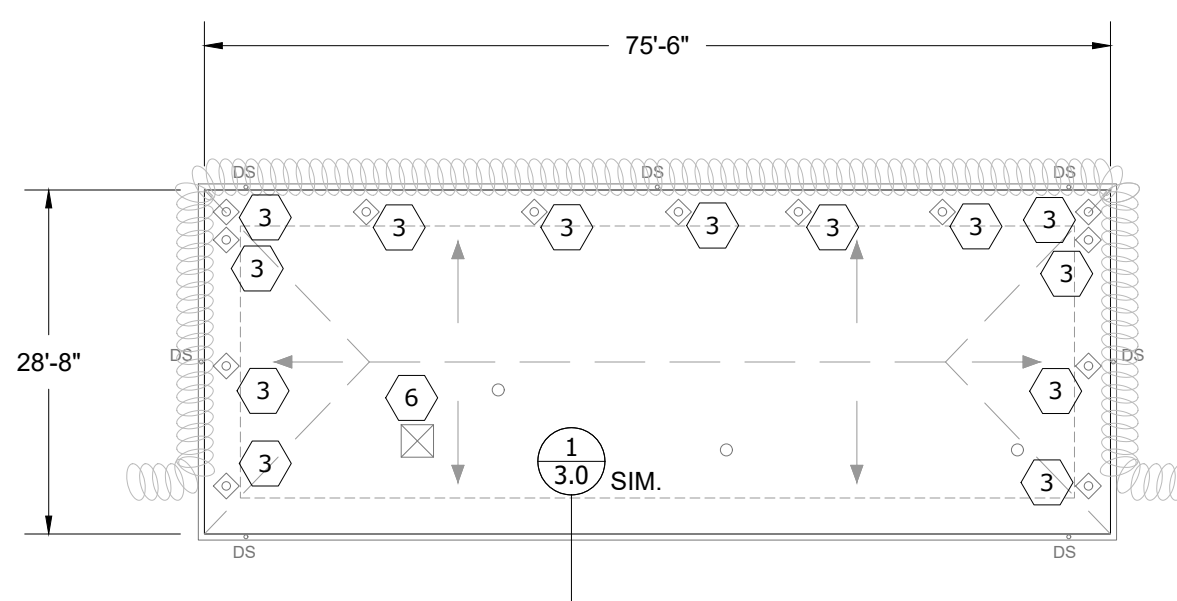
3 GATEHOUSE BUILDINGS  
 2.0 SCALE: 1/16" = 1'-0"

NOTE:  
 - COORDINATE TEMPORARY REMOVAL OF EXISTING BARBED WIRE AT THE PERIMETER WITH NCDAC AND FACILITY TO ALLOW FOR WORK.  
 3 - ALL EXISTING PENETRATION POCKETS.

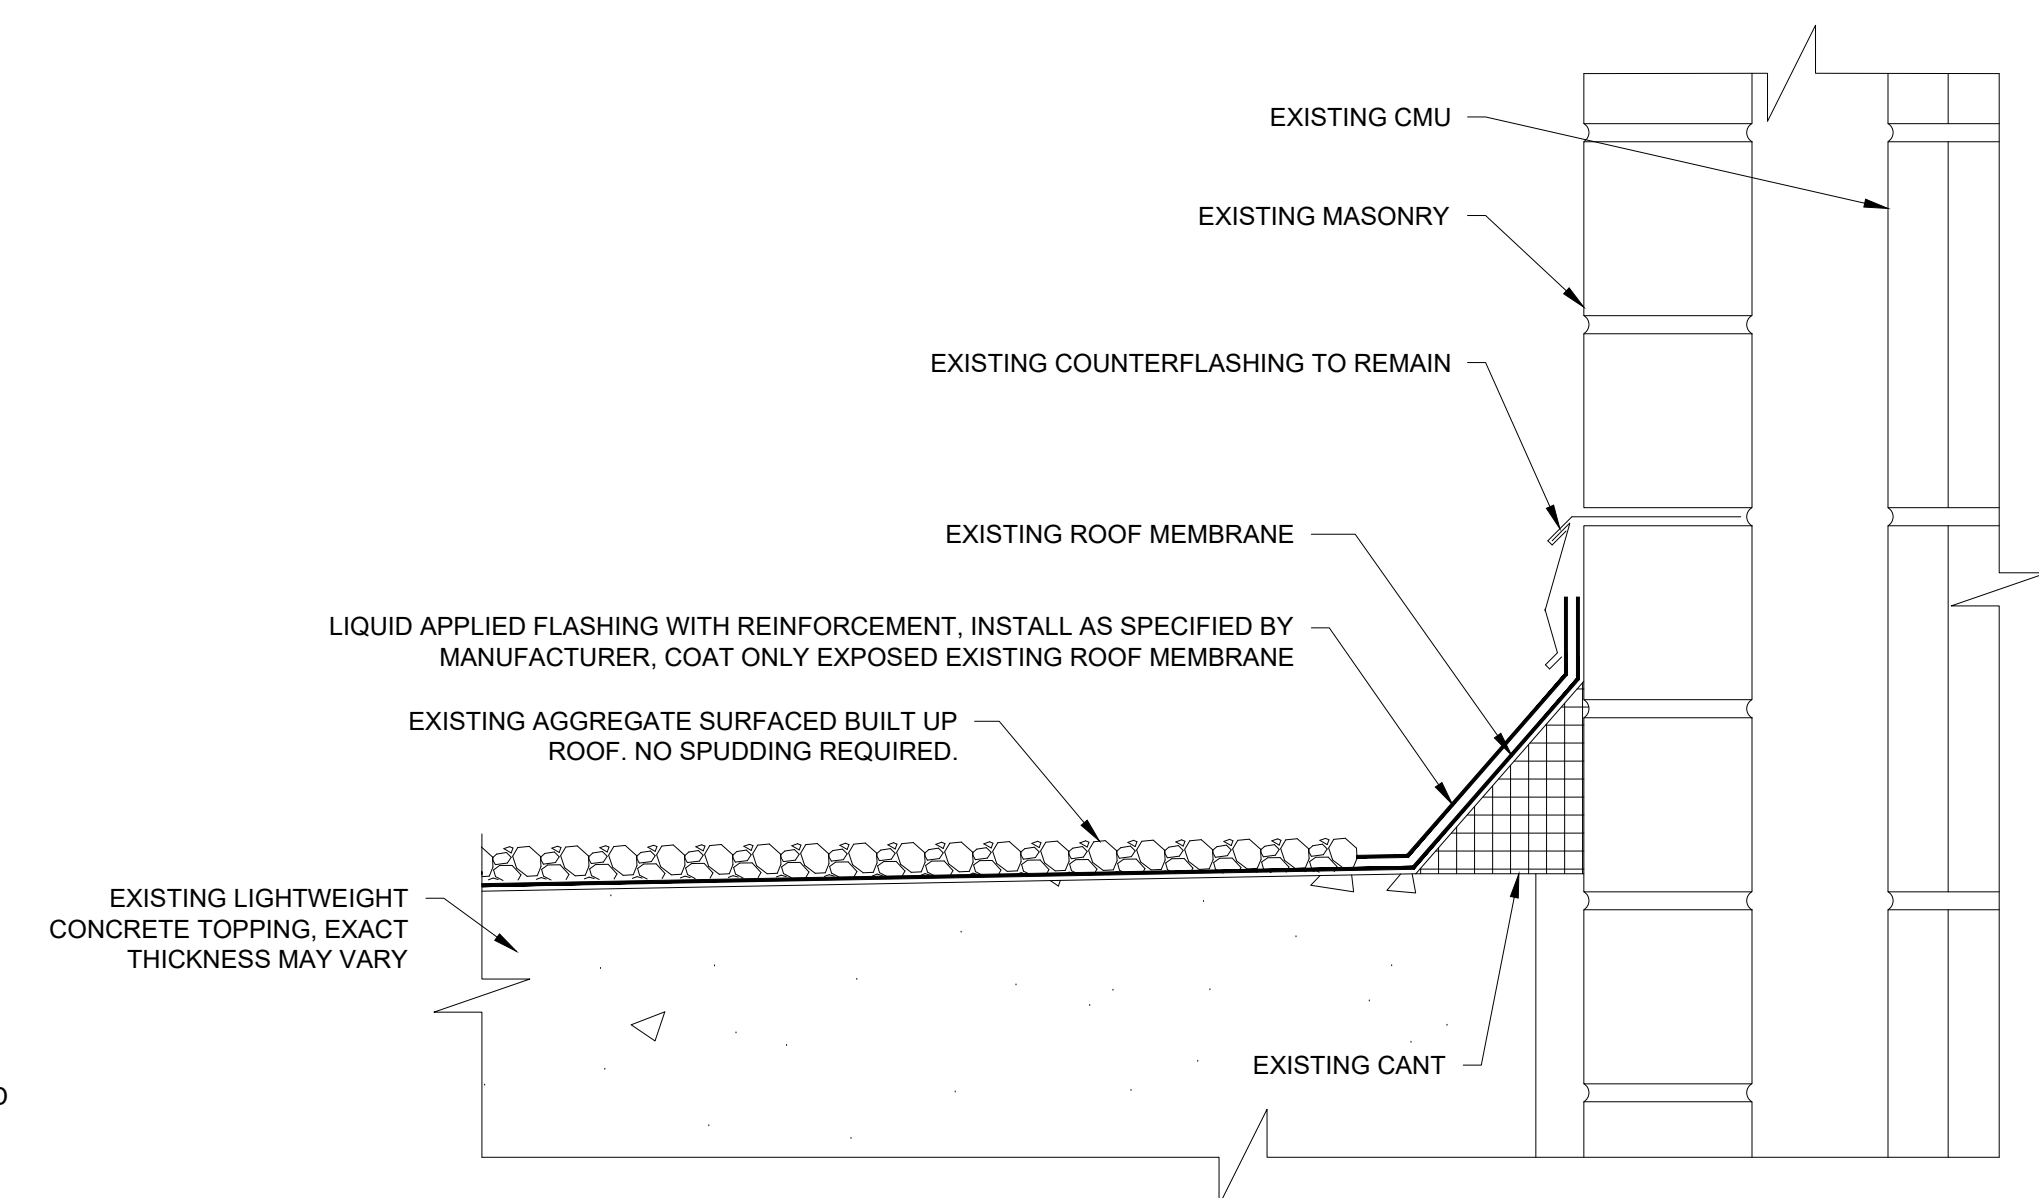
**2** ROOF TO WALL TRANSITION FLASHING  
3.0 SCALE: 3" = 1'-0"
